Specified Property Assessment Report
for rehab project purposes

1749 W. Chicago Ave.
Chicago, IL

Inspection Date: 5-19-17

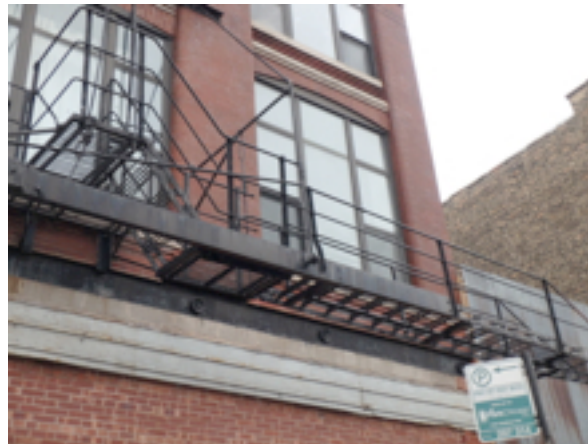
Fire escape views, fire escape was not accessed during inspection, no signs of pull out

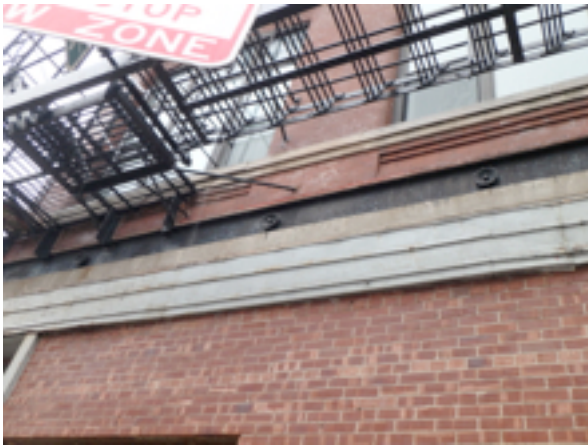
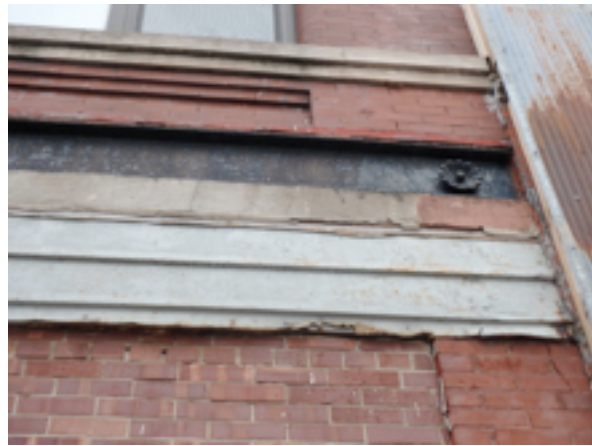
Main beam views and poor wall cover conditions at face wall

- Front wall erosion repairs are not optional. Masonry repair costs will only get higher as time and erosion march on
- The buff colored mortar parging along with the two rows of gray metal wall capping under the black beam in the above pictures all need to be removed so that wall areas can be properly serviced and closed

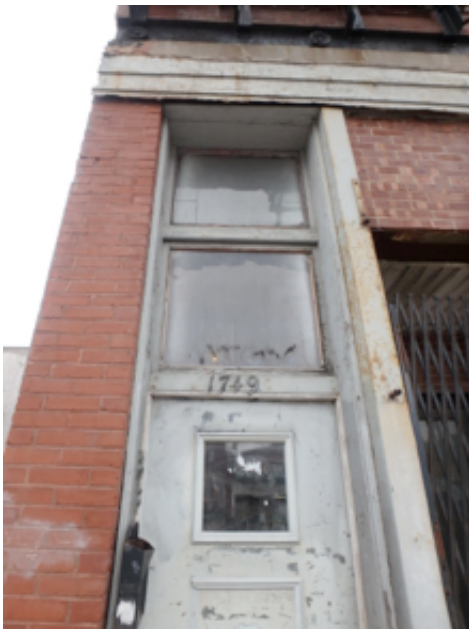
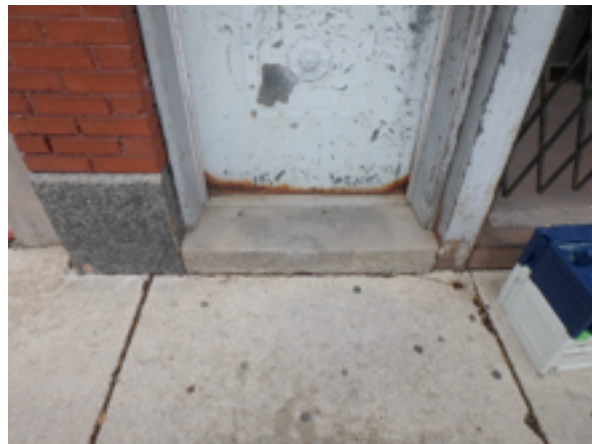
No signs of major movement at doorway, typical repairs should be fine

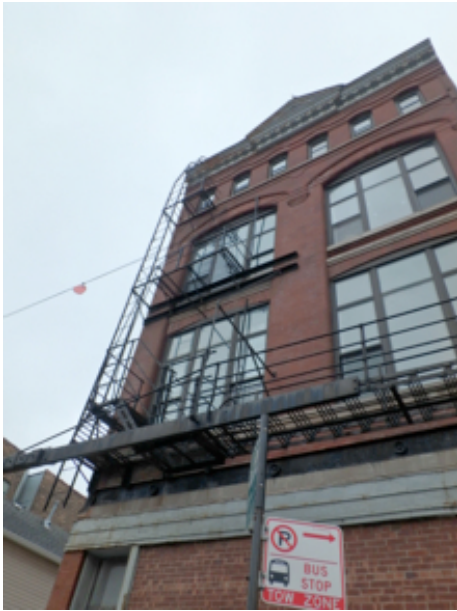
Front wall and cornice views

- No signs of major detachment at front cornice. There are some rust holes that will need repair but those are fairly standard. Full priming and painting will be needed.
- You may want to consider review historical color patterns for the cornice work.
- Between face wall cleaning and cornice work this could be a really beautiful building along the street

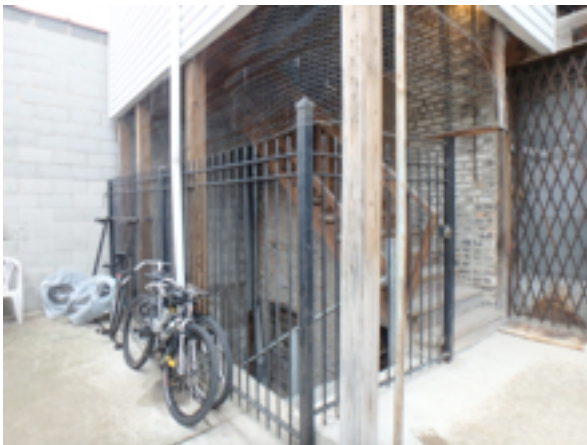
Rear of building entry area

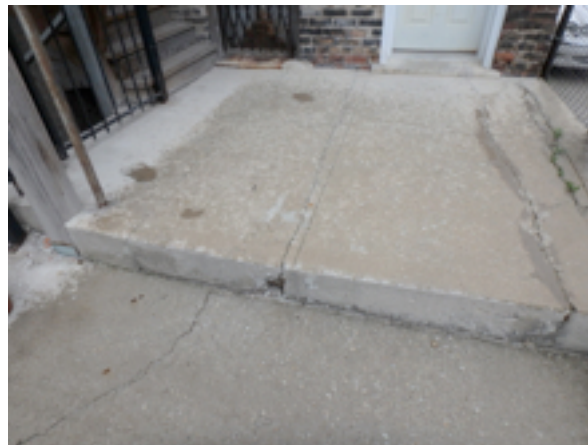
Multiple full length pad cracks

- The above concrete pad will need replacement at some point. Conditions aren't very good and City inspectors are unlikely to be happy with this pad; especially if they see the underside.

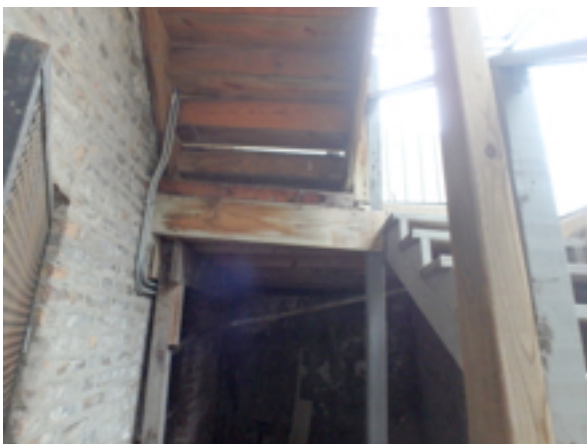
Lots of water saturation at wood

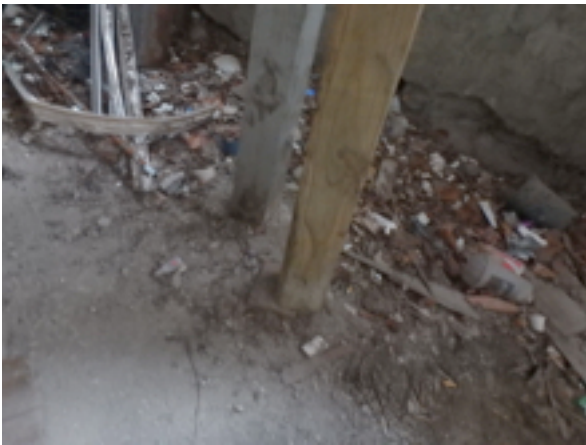
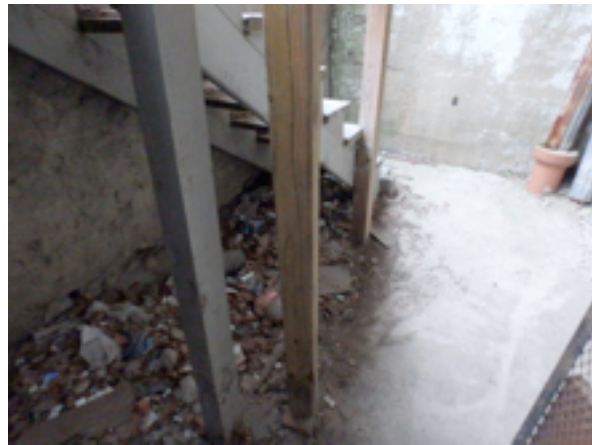
No post bases and very dirty conditions

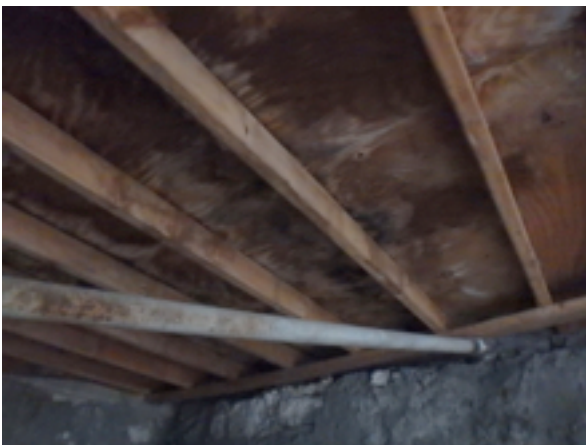
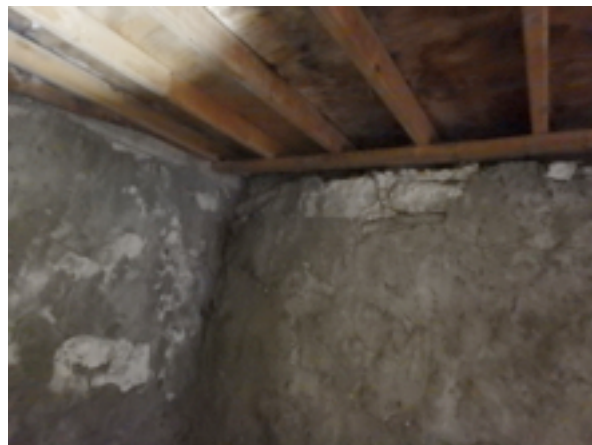
Heavy water saturation, rot and wall deterioration signs under grade level pad

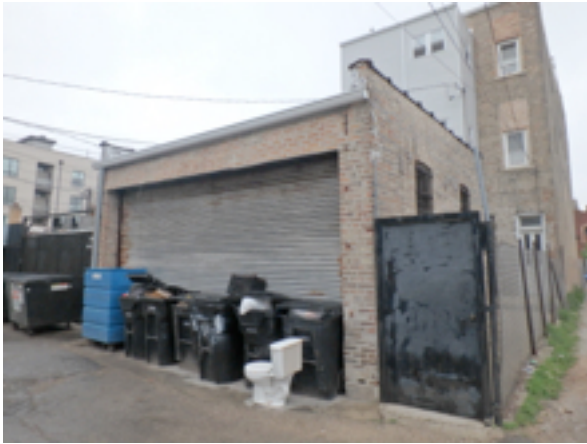
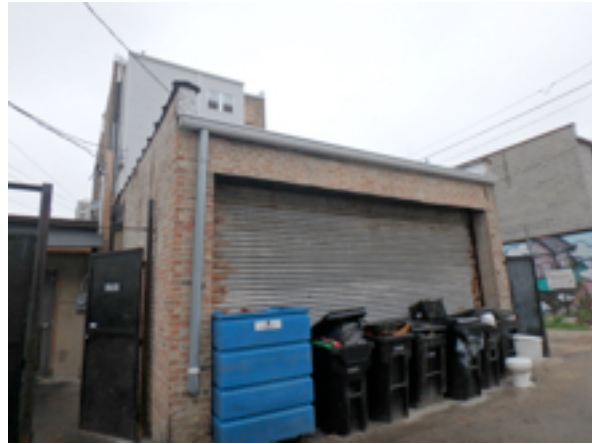
Garage views from the alley, overall not bad

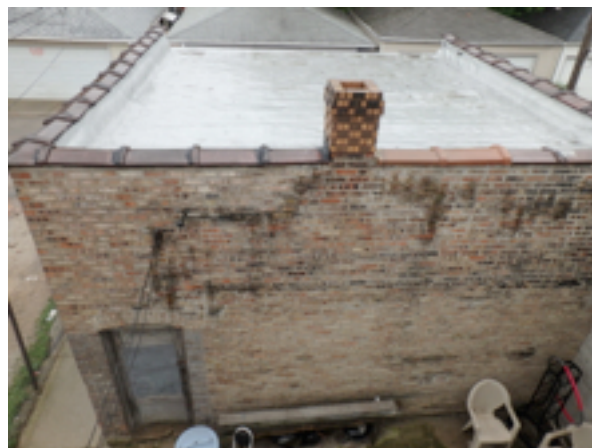
Wall erosion signs due to open chimney

- The top of the chimney needs either a proper cap and rain hat or to be closed off to stop water coming into the wall
- Chimney closure cost is far less than what wall repair costs will be if the chimney isn't dealt with

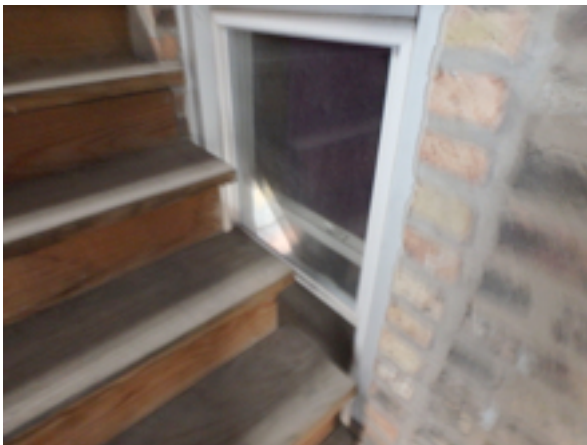
No guardrail along window

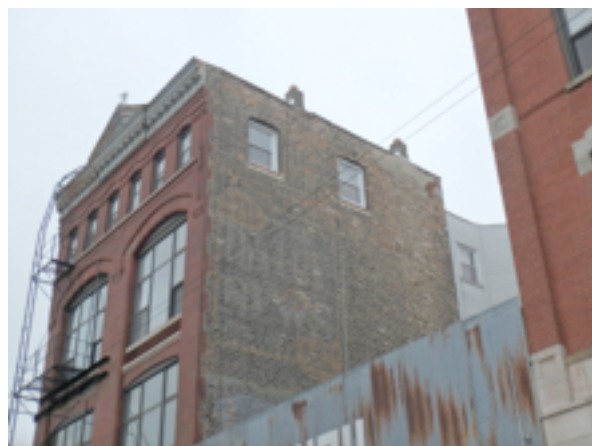
W elevation view, wall mostly ok but parapets need work

- Don't forget to budget for siding and roofing repairs at the W elevation light well
- If you decide to install storefront AC or make up air equipment on the W light well roof, replace the roof first

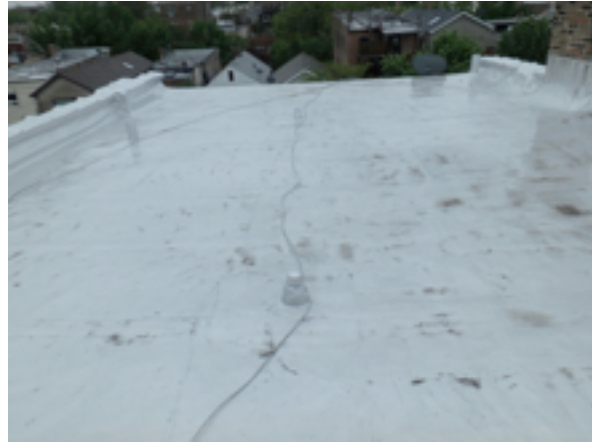
General roof views, some wrinkled and bubbles not no major heaving

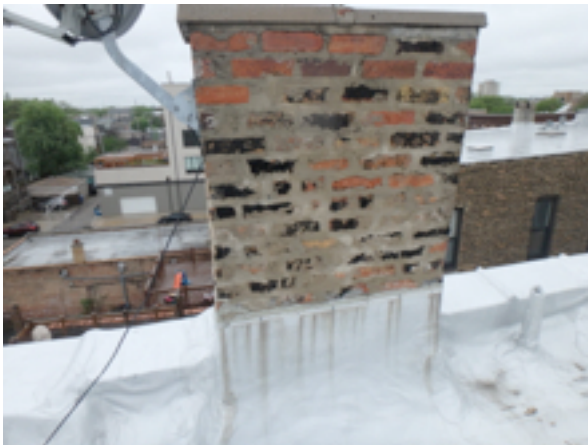
Average chimney conditions

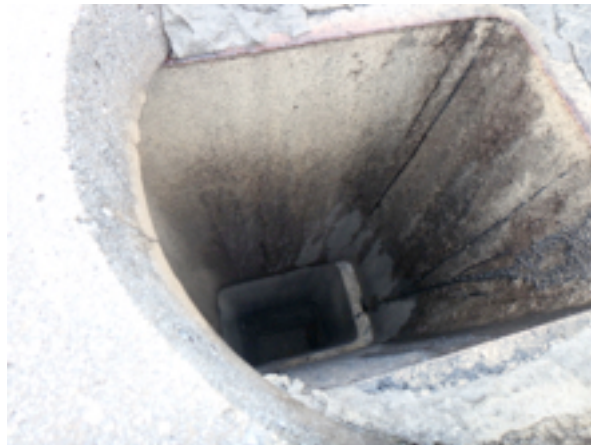
Typical shifted clay liner sections

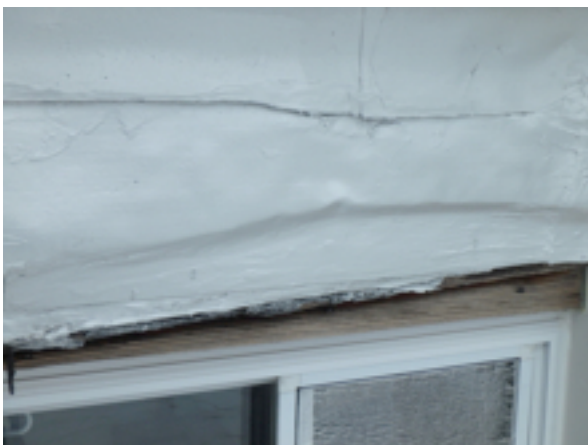
Less than ideal roof to window terminations, will likely lead to rot out at tops of windows

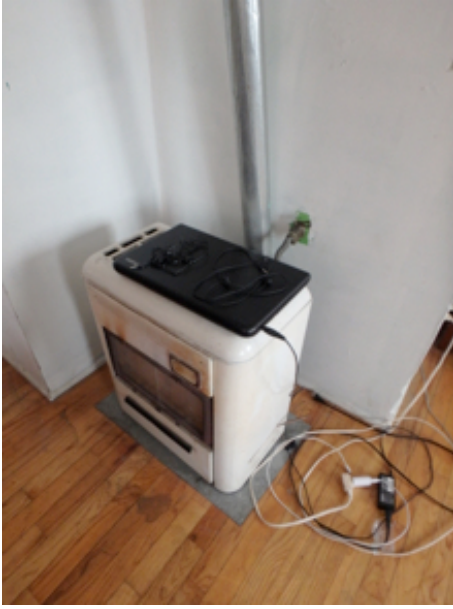
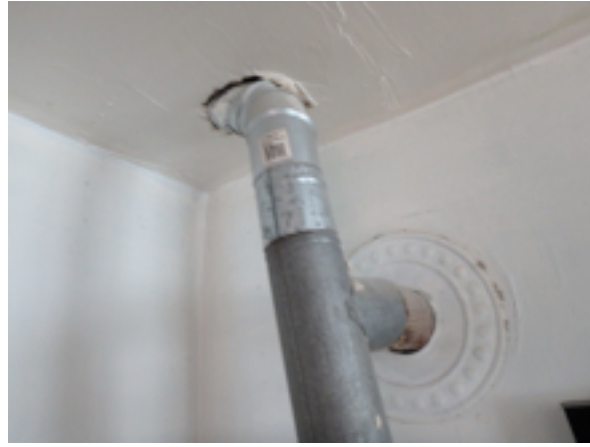
Typical older space heater with less than ideal flue pipe set up, typical deterioration at unit

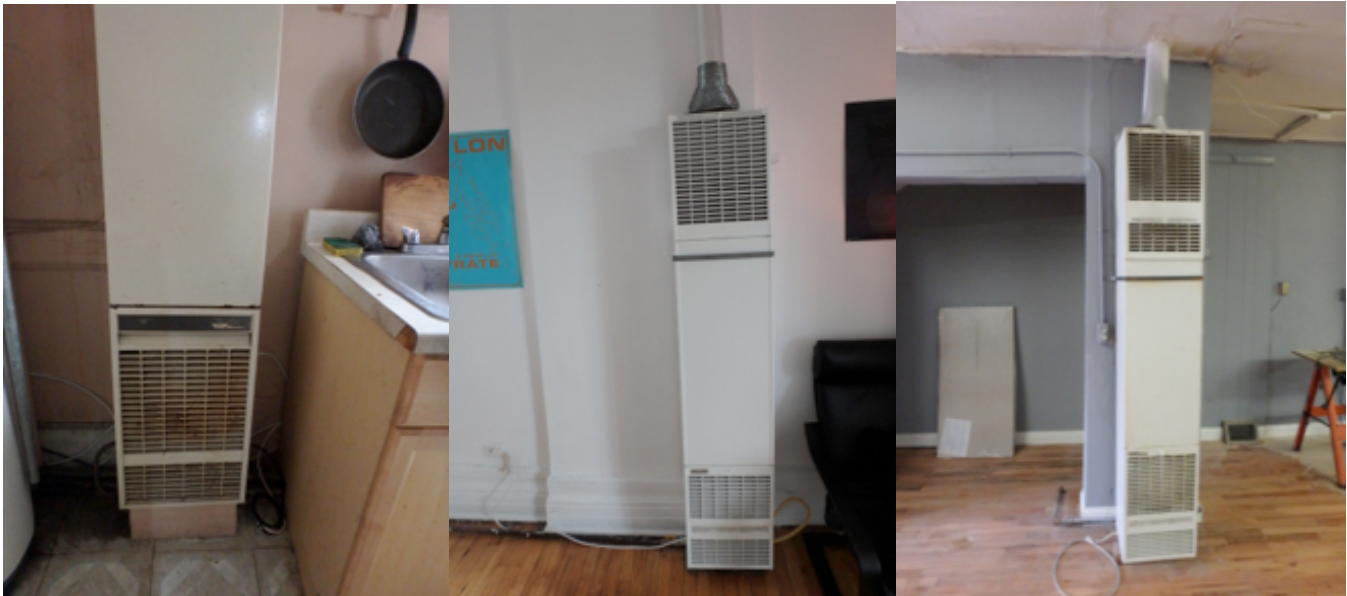
Typical mid-age Williams space heaters, better condition but still not ideal

- Install new HVAC system for each apartment
- Continuing to use space heaters is not a viable option under rehab

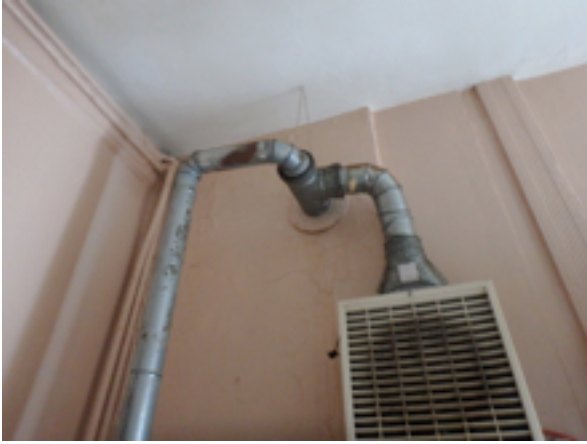
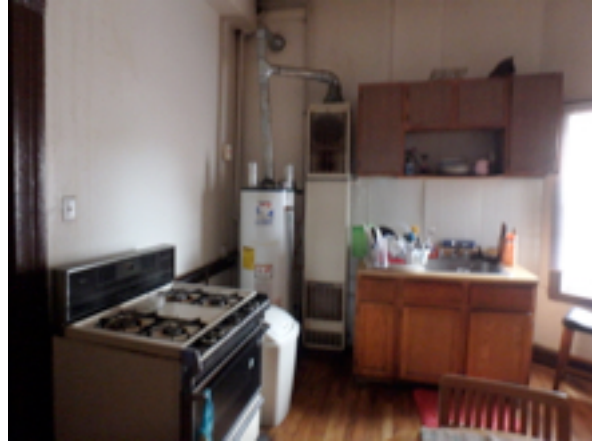
Space heaters dirty, poor flue pipe configurations, unit positions don't provide for good distribution

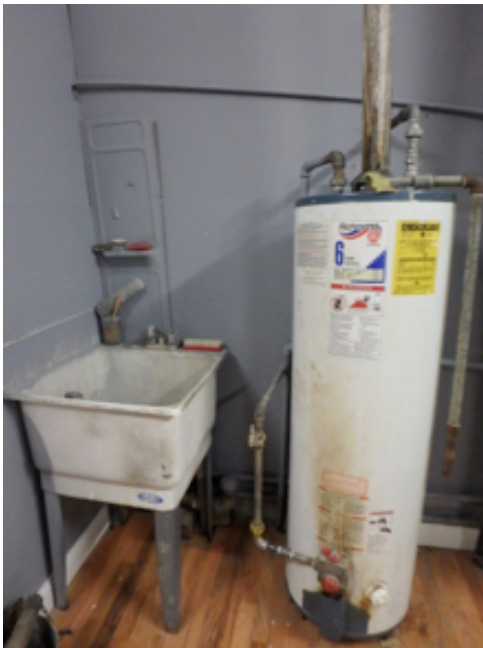
Flame roll out signs at storefront water heater

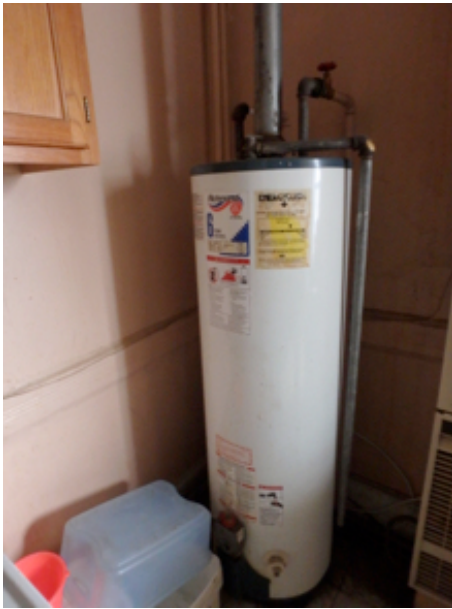
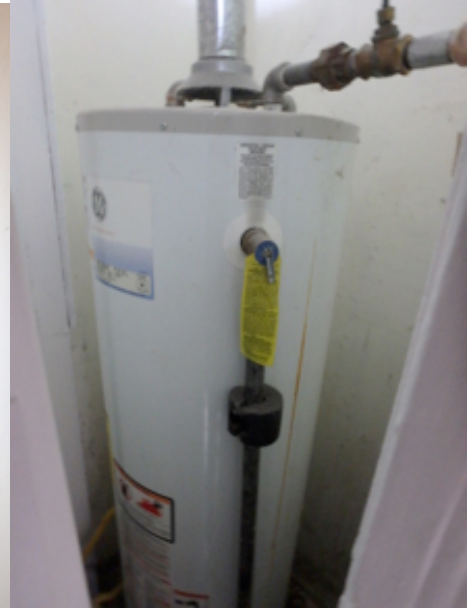
Typical water heaters in kitchens and closets, budget for full replacements

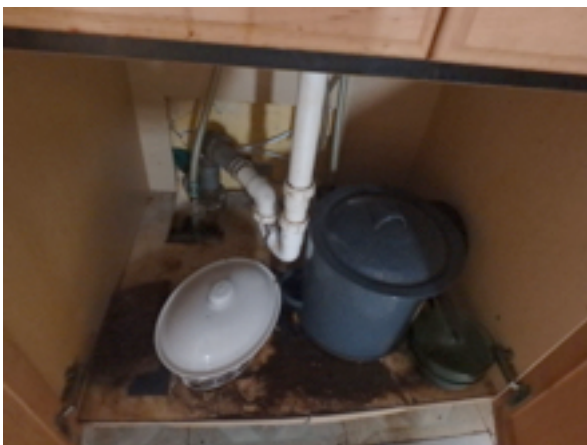
Typical poor older plumbing

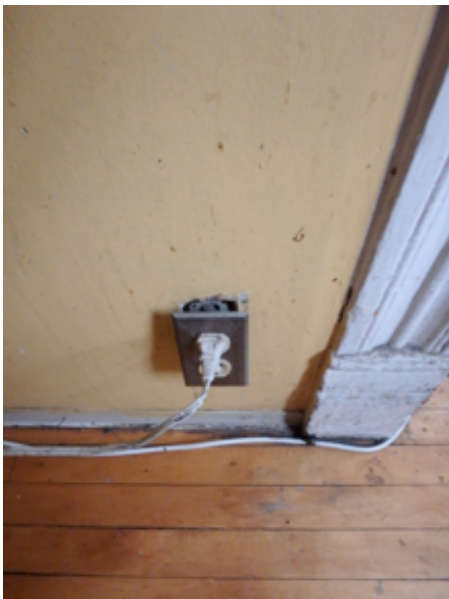
Typical poor and damaged electrical infrastructure in building

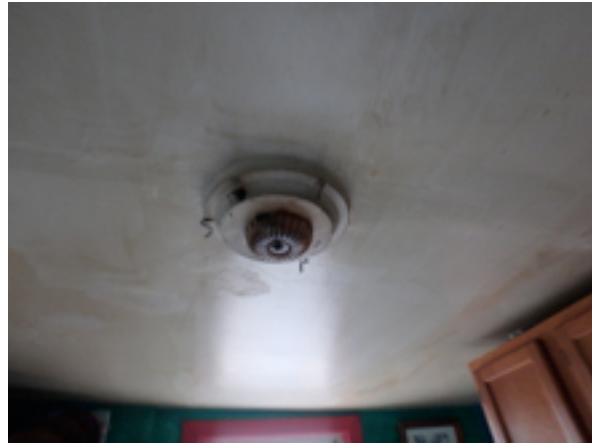
Not exactly functional lights at multiple locations

- Tenants using lots of extension cords to make up for poor lighting and lack of sufficient modern receptacles. This can pose additional electrical fire concerns
- The above open ceiling area is located above the dropped ceiling in one of the apartment bathrooms
- All painted receptacles need to be replaced

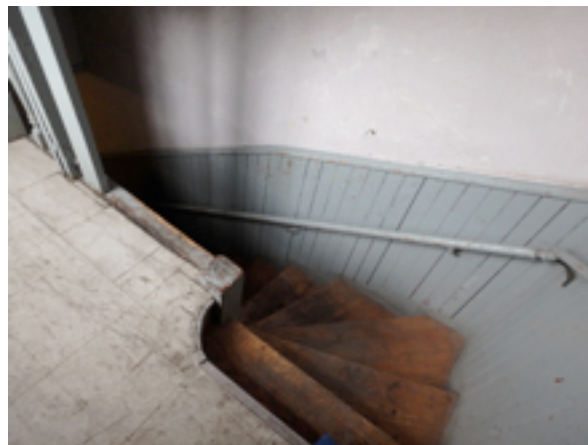
Typical corridor view, overall not bad

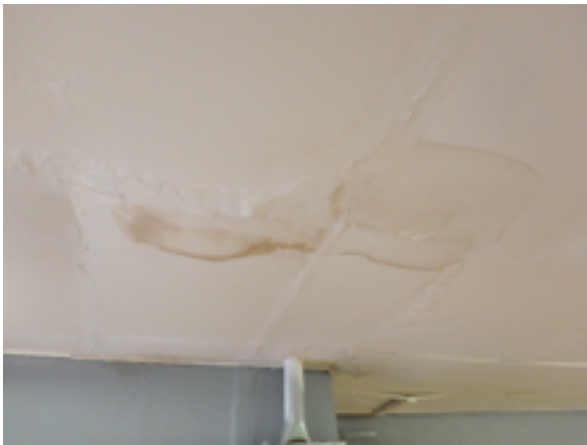
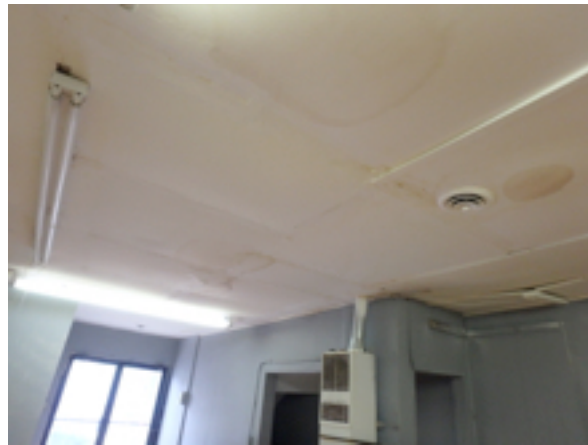
Typical water damage likely from plumbing leaks

- Patching wall cracks is fine and tends to work out well
- Patching ceilings often isn't your best option. Ceiling plaster is often detached from lath underneath thereby no longer being structurally sound. Even if you repair the crack the plaster is detached from the lath.

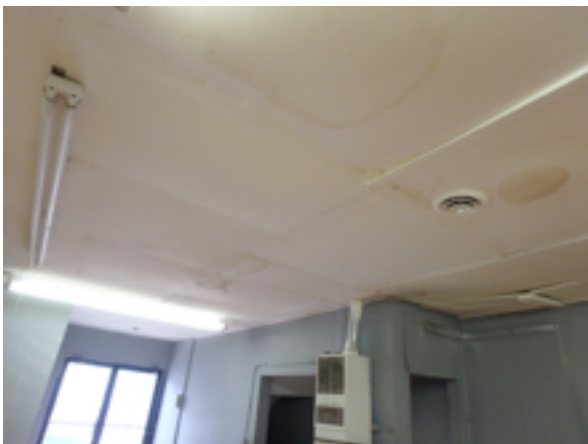
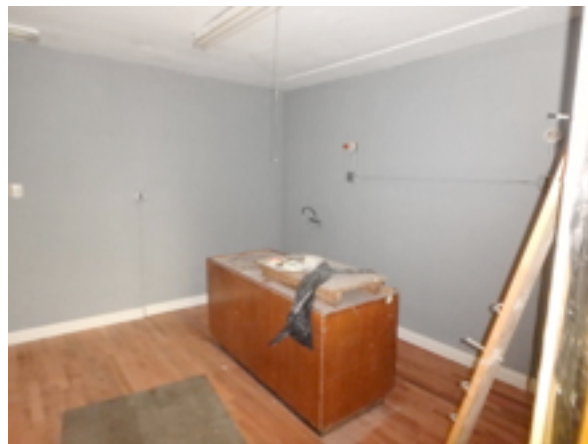
Storefront ceiling with water damage

- While the storefront interior looks pretty decent stripping down walls and ceiling areas to framing might be your better option. This will add cost but tends to make for more reliable installations and easier mechanical installations
- Due to water damage part of the ceiling needs to come down anyway

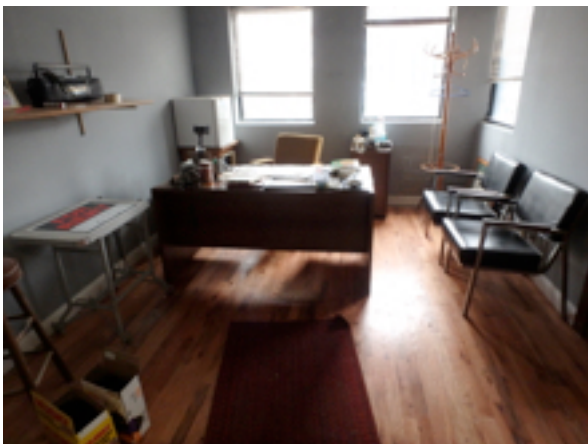
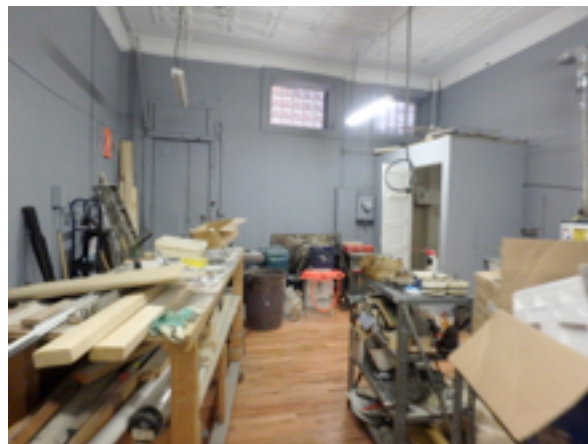
Front office and rear work area, all doorways will need EXIT signs

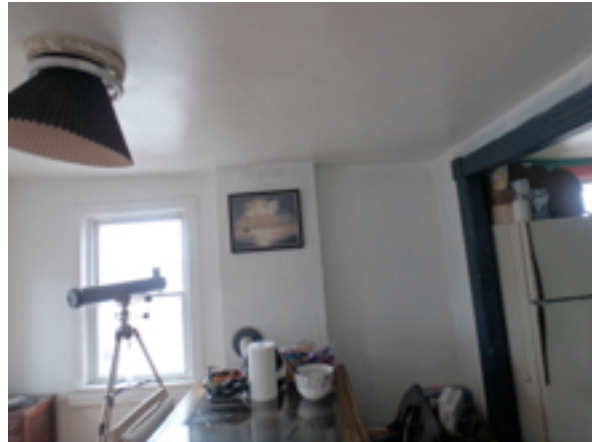
General conditions look good but the details show the problems

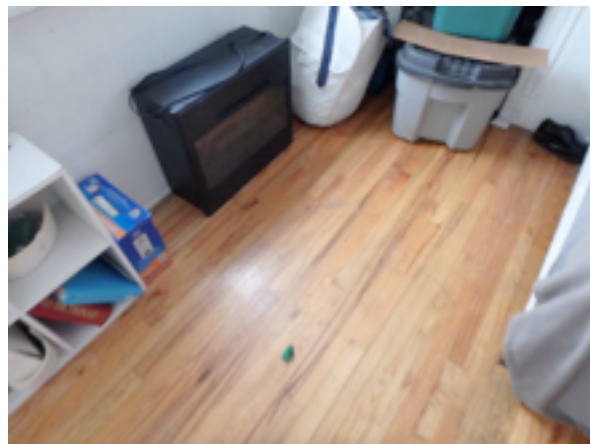
Some floors look ok, some floors a bit rough, sanding and refinishing should be fine

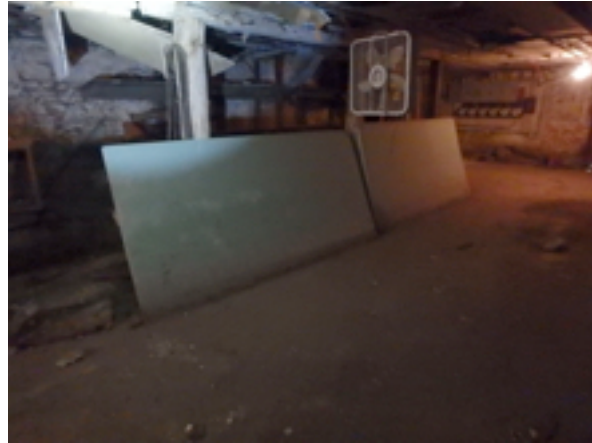
Basement stairway view and flood line along drywall

- The basement is a flood and rat disaster at this point. Moisture levels are very high; termite type damage is evident at some wood components; and structural problems are abundant.

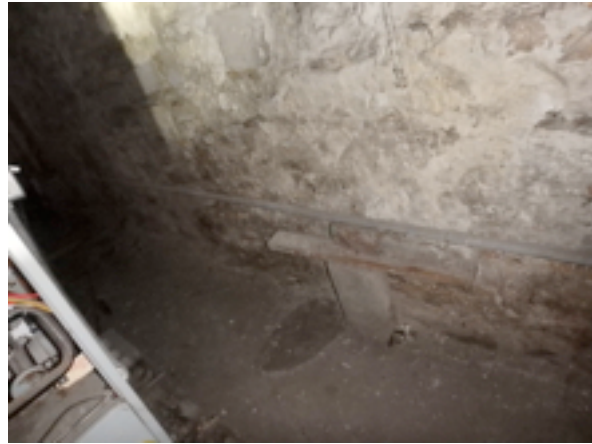
Typical old stone foundation walls with erosion

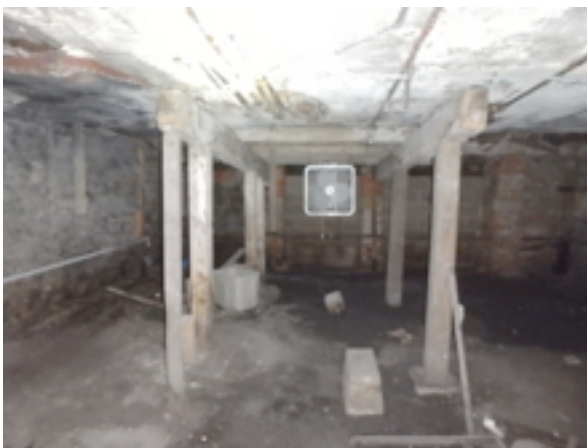
View towards front of basement

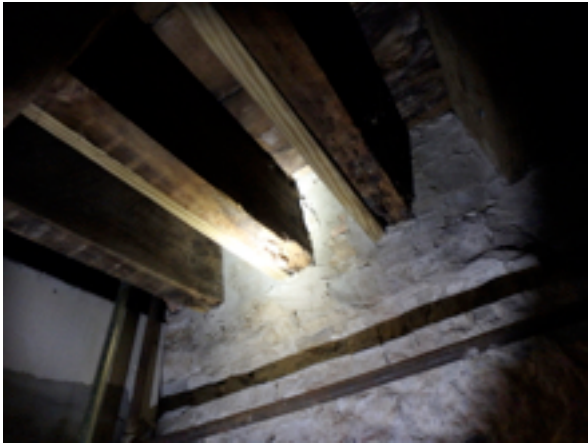
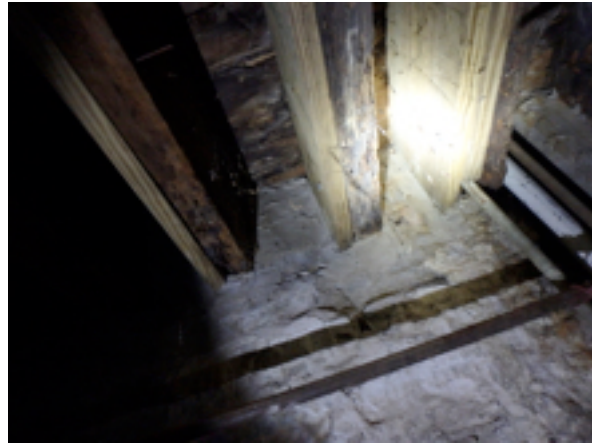
Termite type damage at multiple wood joists and poor sistering work

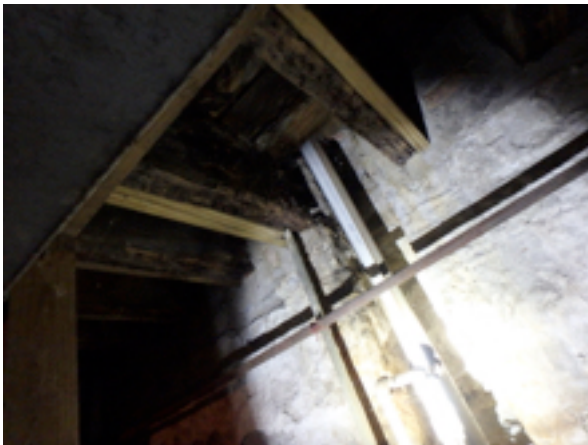
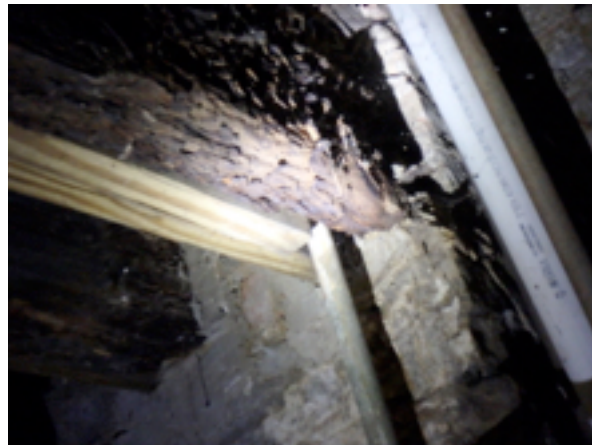
Joists and mid span supports will all need extensive carpentry repairs

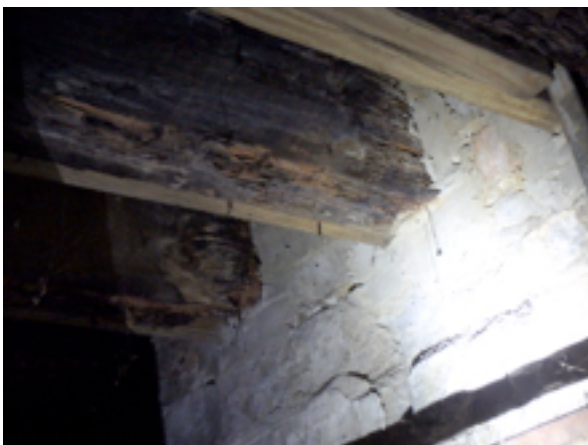
Another view of termite type damage at joists

- You'll need to hire a qualified carpenter to provide joist improvements along with new mid span post and beam replacements
- Costs for this type of work tend to run high. The City will want to see Plans by a licensed Architect or Structural Engineer
- At least 6+ joists with termite type damage and undersized bolts for sistering

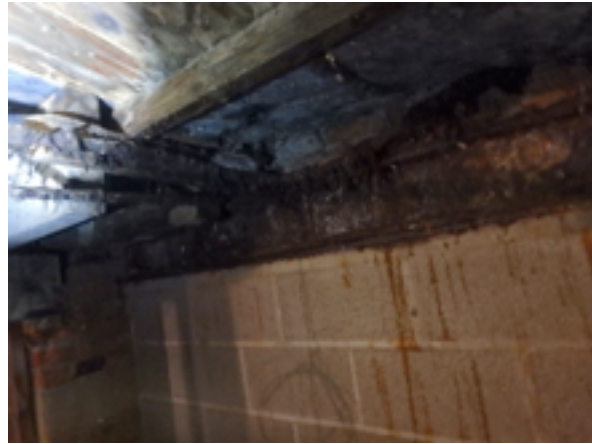
Front CMU wall with extensive rust and water intrusion signs

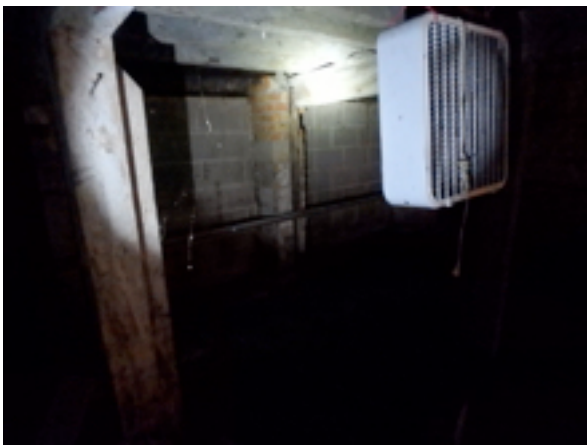
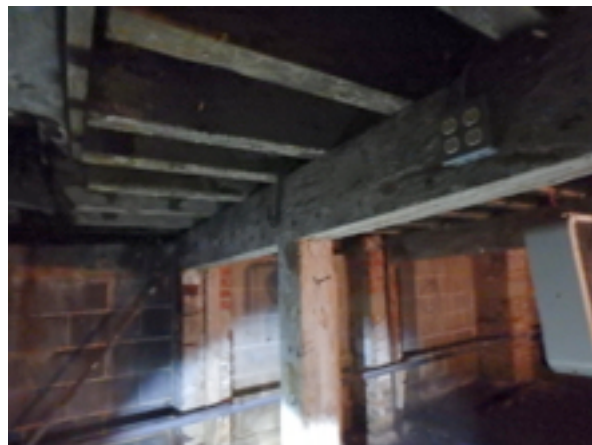
Rotted mid span beam, various additional support added at front of basement

- The majority of basement water intrusion appears to be coming from the front wall. However, there was no seepage or flooding during the inspection so I can't say for sure.

- How you resolve issues will depend on what you find.
- Since you will likely be dealing with basement plumbing installing drainage along the front wall might be a good option.

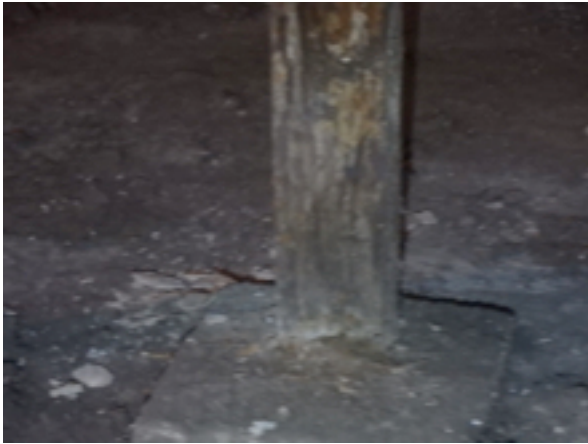
Typical mid span post rotted out at Floor level, all need replacement

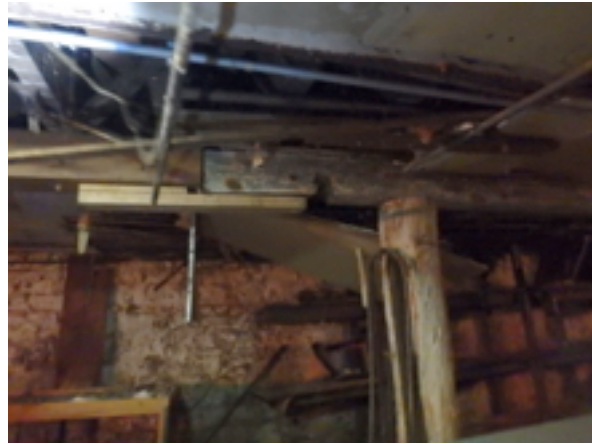
Poor beam and joist conditions

- Proper footings will need to be poured for all new mid span support posts

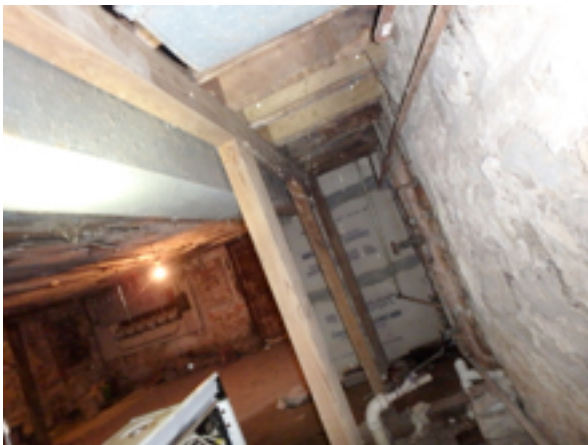
Poor joist tie-ins

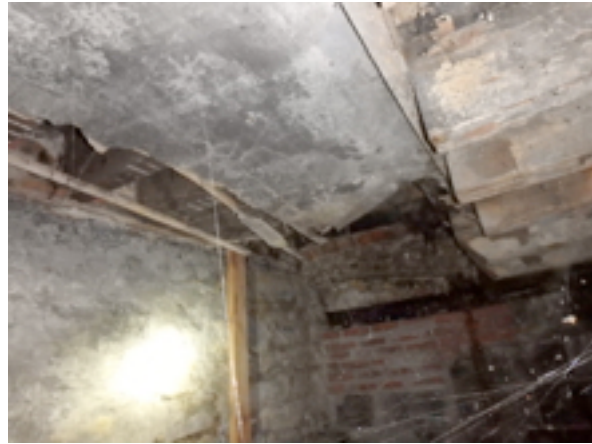
Typical poor ceiling conditions, all needs to be stripped up to joists
