Specified Property Assessment Report
for rehab project purposes

1749 W. Chicago Ave.
Chicago, IL

Inspection Date: 5-19-17

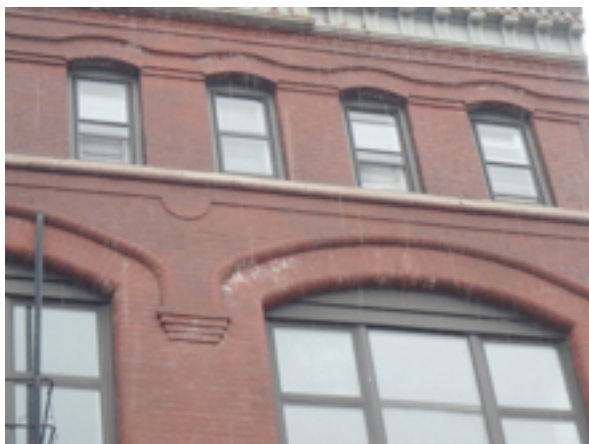
The white color on brick is water Saturation into the wall

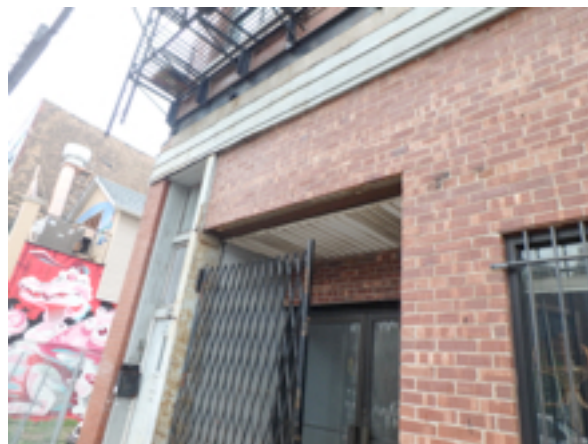
No signs of sagging at doorway lintel

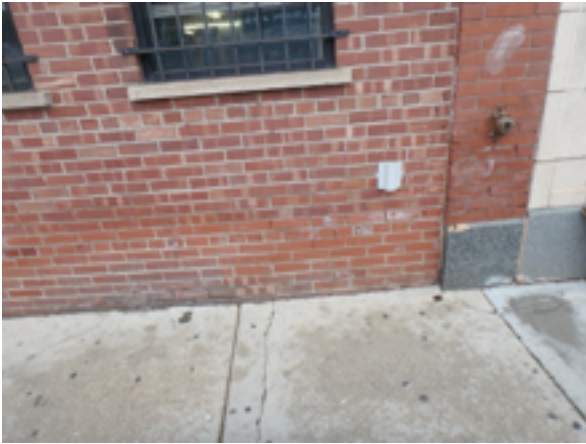
Erosion along bottom of front wall

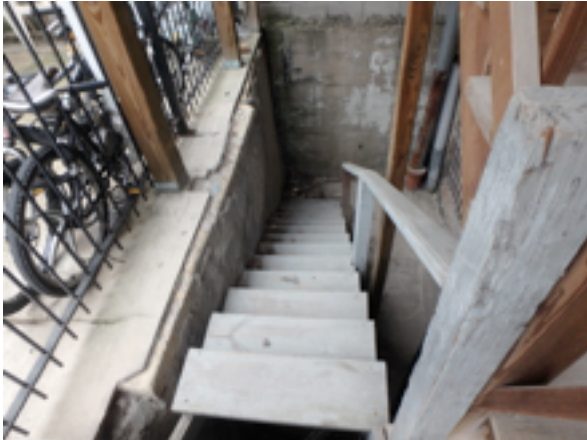
Stairway not fully compliant

- City inspectors would most likely want to see the stairs rebuilt under a rehab Plan. The stairway and guardrail are not fully compliant and in poor condition. Stringer condition and attachment are the primary issues.
- Concrete at the rear yard area is essentially funneling water at the large retaining wall. You can postpone repairs until the end of a rehab project but nonetheless money will be needed for repairs.
- Capping the top of the wall or installing a curb to keep water away from the wall can help reduce deterioration issues
- These types of details are the types of options you need to think about in order to make a rehab budget work and assess additional costs in the short to mid term
- What you don't fix now will need to be fixed later so more money needs to come from somewhere at some point

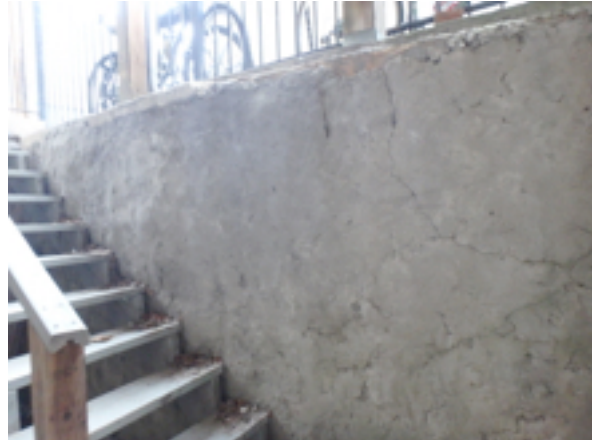
Retaining wall bulging inward

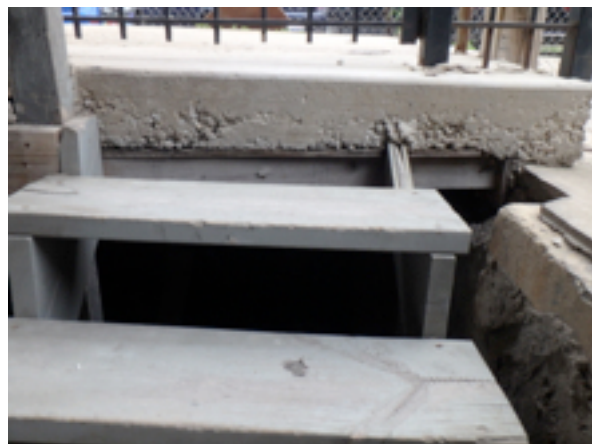
Poor stringer attachment

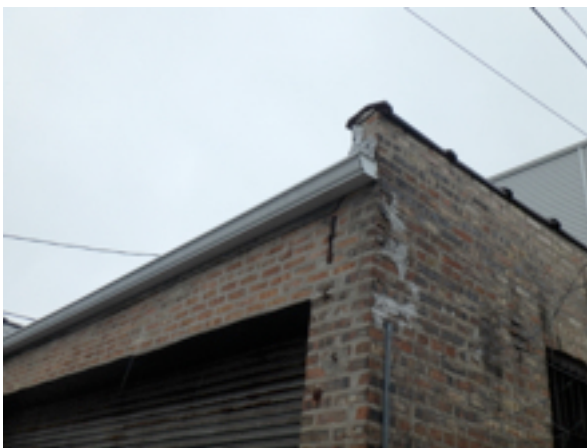
Typical wall erosion signs

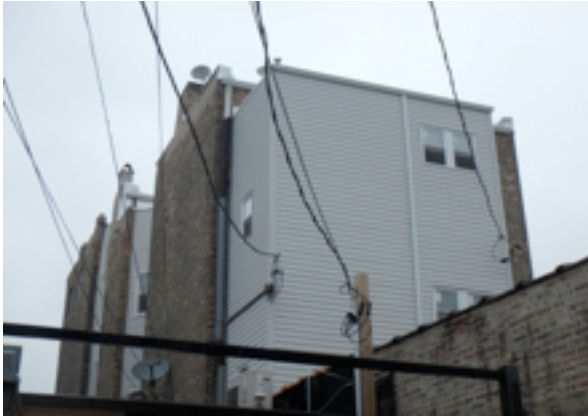
Rear of building view with enclosure

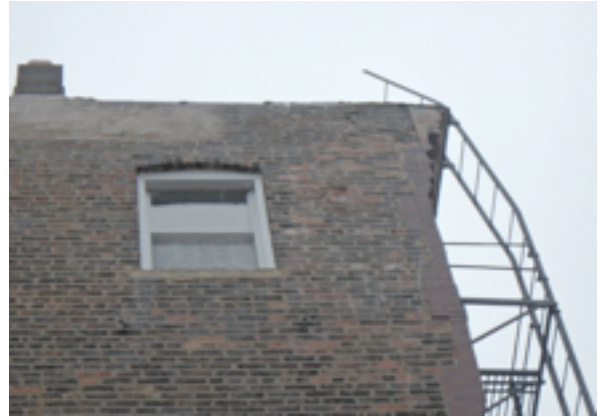
Typical erosion at front corners

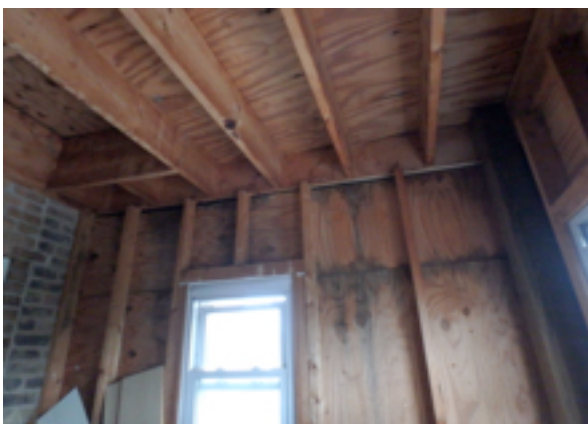
More signs of water intrusion and rot at porch enclosure

- You need a contingency budget to deal with the rear porch siding and water intrusion issues. At some point the plywood will be severely rotted out and siding will no longer be securely attached
- You could provide repairs as soon as feasible to stop water intrusion and not deal with the rotted plywood anytime soon. However, given probable rehab timelines you might want to budget to strip and re-clad the porch.
- Depending on the rehab Plan you may also want to budget for demo and replacement

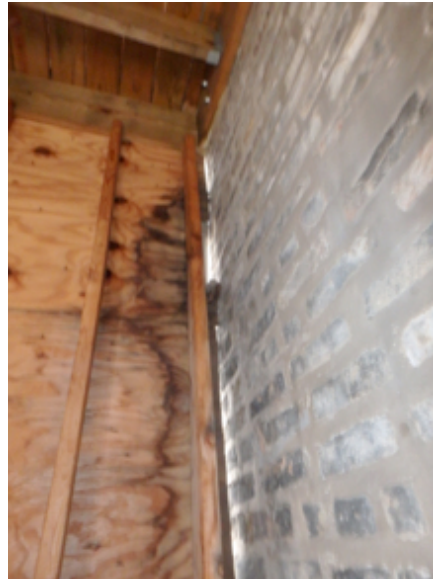
Water damage from downspout along the Exterior of the wall

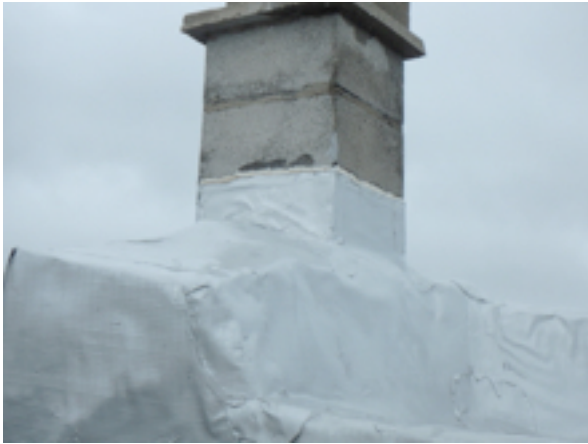
Typical poor installation, no term bar

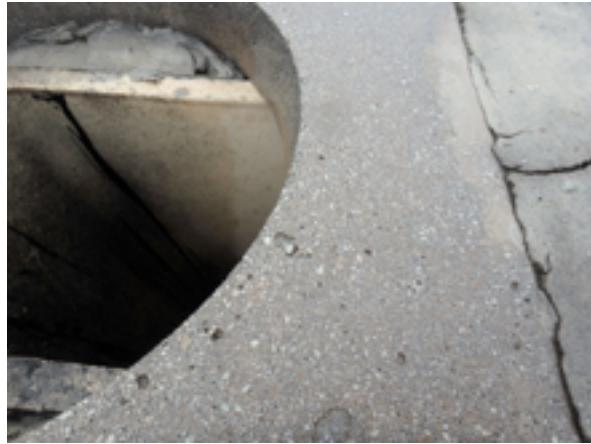
Typical poor open joints at top of chimney

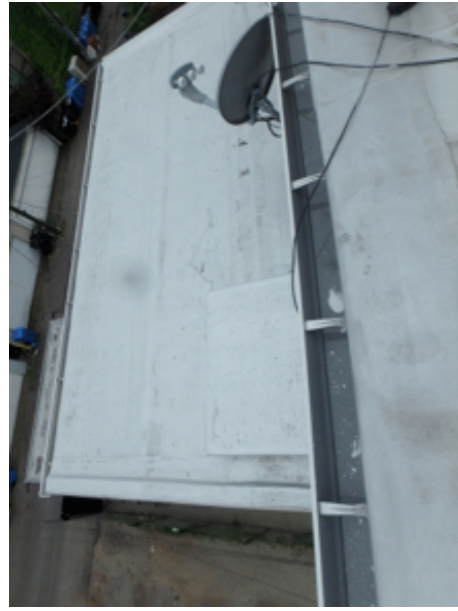
Rear porch roof view, overall ok

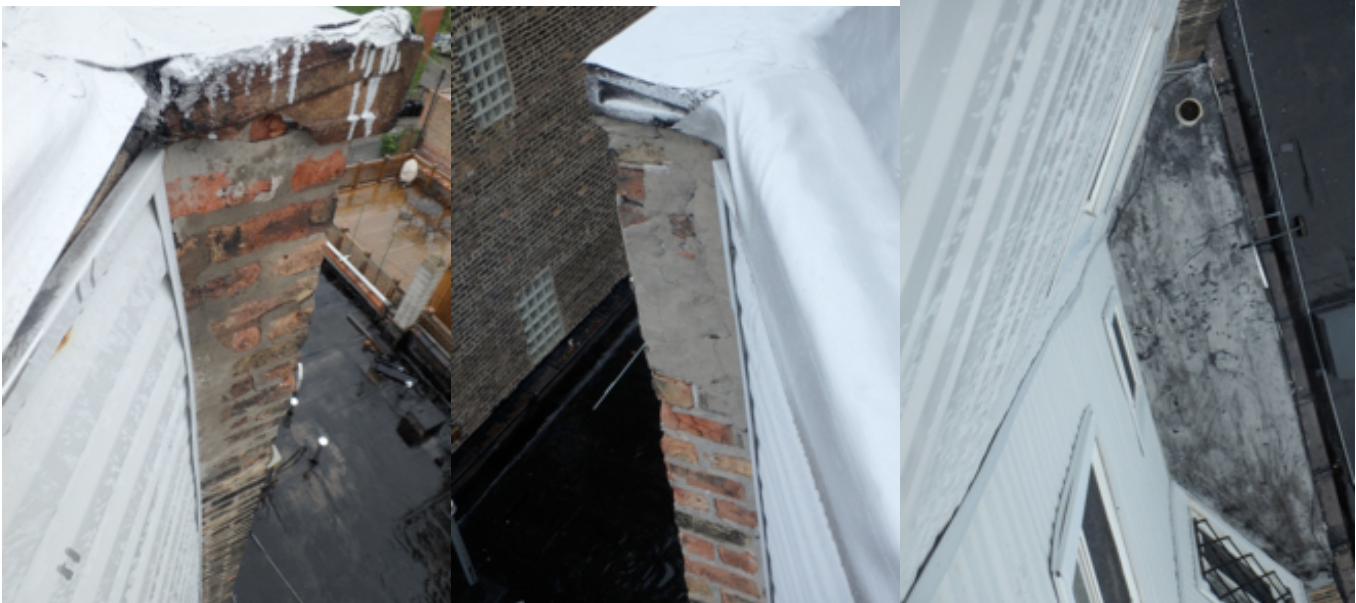
W elevation light well wall and roof views, needs servicing as part of rehab

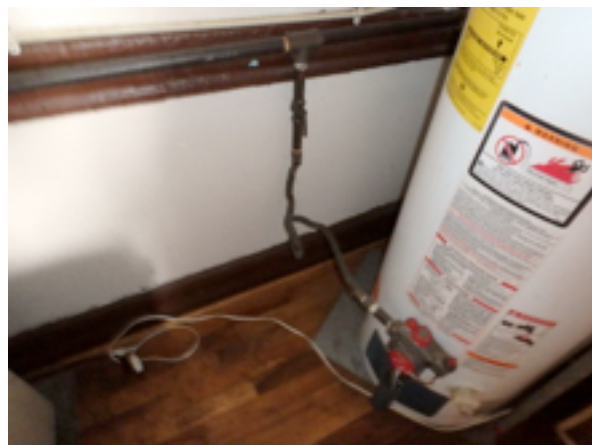
Poor gas connection at water tank

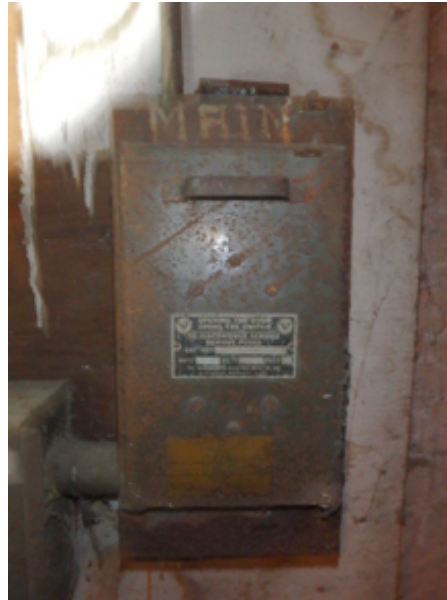
Old main disconnect

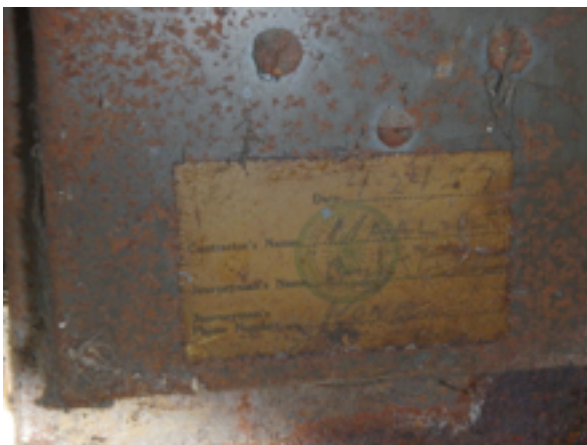
Original installation tag from 1957

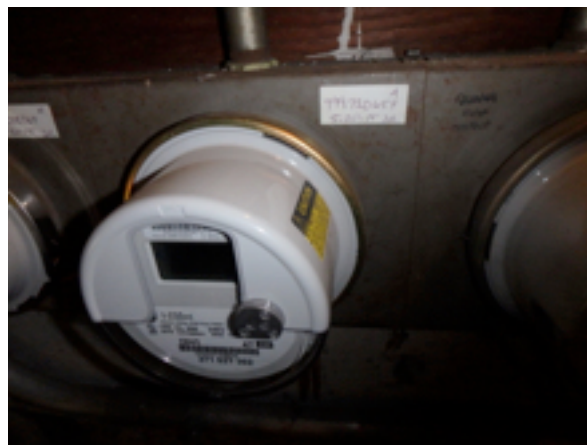
Newer ComEd smart meters installed

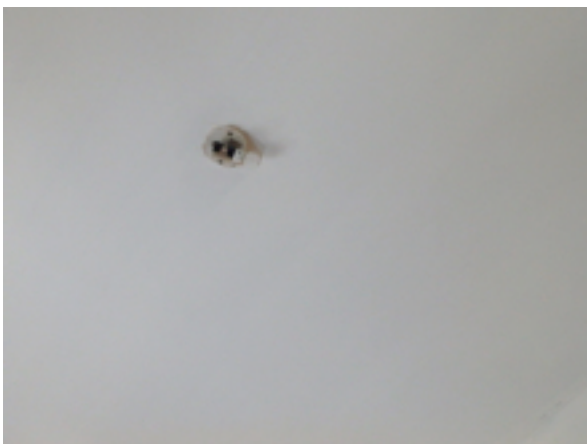
Typical damaged smoke detector

- No working smoke or carbon monoxide detectors located. They could be there somewhere but I did not note any. This is considered a hazardous condition given that each apartment contains multiple gas burning appliances
- I urge you to install new smoke and carbon monoxide detectors immediately as required and for improved safety
