Specified Property Assessment Report
for rehab project purposes

1749 W. Chicago Ave.
Chicago, IL

Inspection Date: 5-19-17

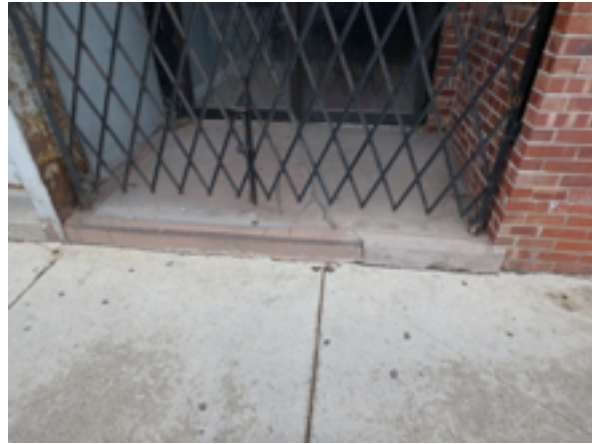
Step up at storefront entry

- I suggest you consider removing the step up at the storefront entry and replacing it with a sloped ramp in order to provide accessibility compliance
- Rehab plans for the storefront will need to address accessibility requirements

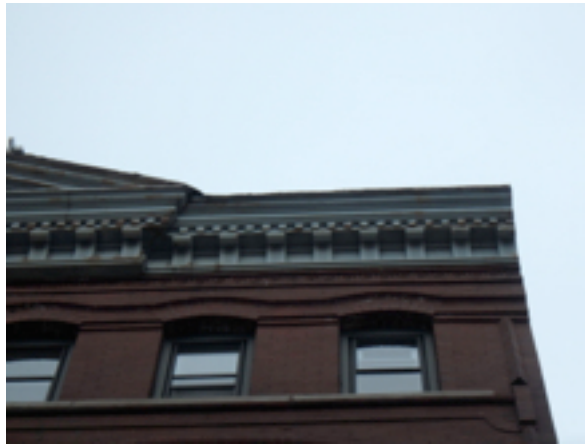
Front wall and cornice views

- No signs of major detachment at front cornice. There are some rust holes that will need repair but those are fairly standard. Full priming and painting will be needed.
- You may want to consider review historical color patterns for the cornice work.
- Between face wall cleaning and cornice work this could be a really beautiful building along the street

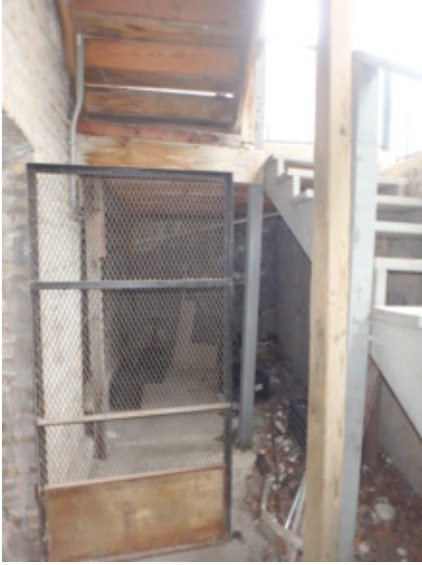
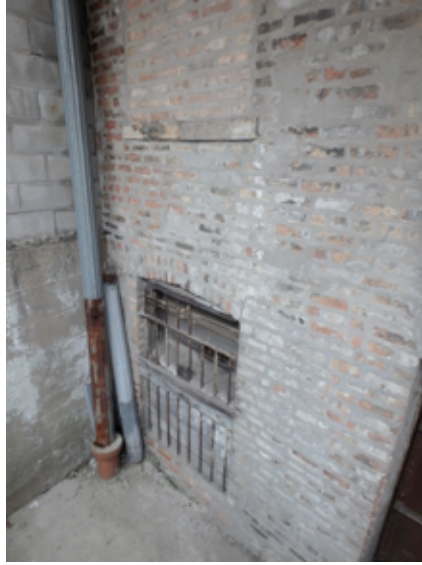
Rusted out downspout likely flooding pad area

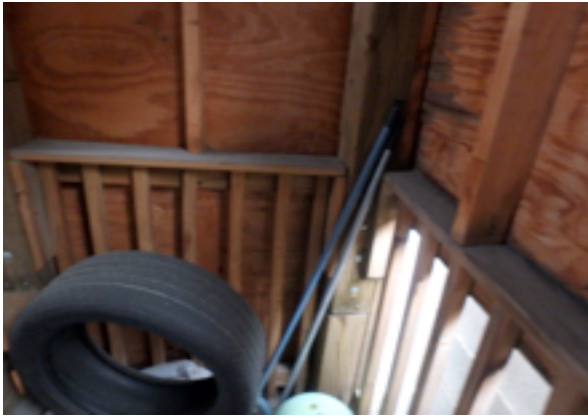
Lots of water intrusion and rotted plywood signs at rear porch enclosure

- You need a contingency budget to deal with the rear porch siding and water intrusion issues. At some point the plywood will be severely rotted out and siding will no longer be securely attached
- You could provide repairs as soon as feasible to stop water intrusion and not deal with the rotted plywood anytime soon. However, given probable rehab timelines you might want to budget to strip and re-clad the porch.
- Depending on the rehab Plan you may also want to budget for demo and replacement

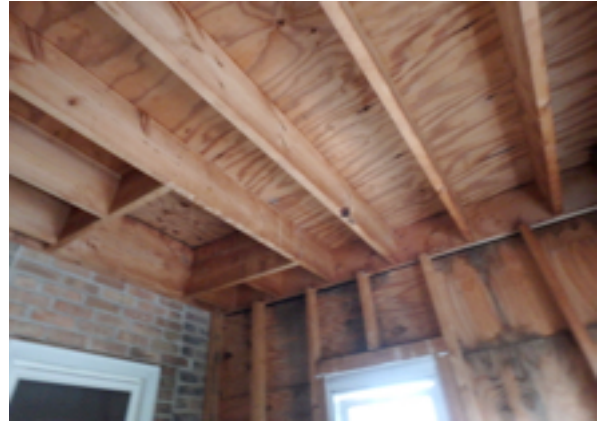
More signs of water intrusion and rot at porch enclosure

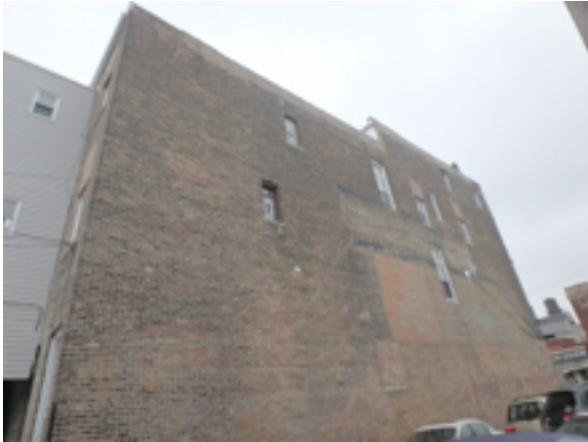
E elevation view, masonry mostly ok, parapet wall needs servicing

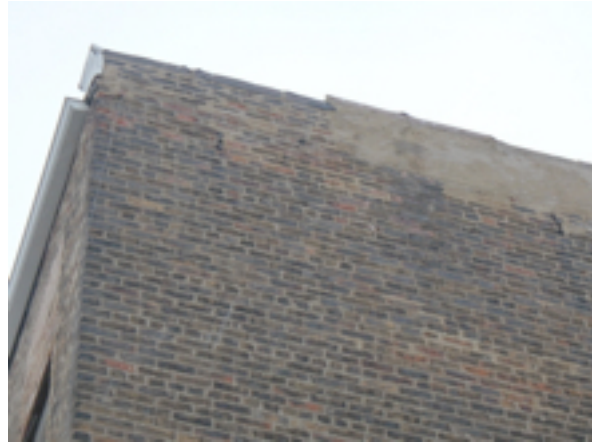
Parapet wall parging view, overall fair

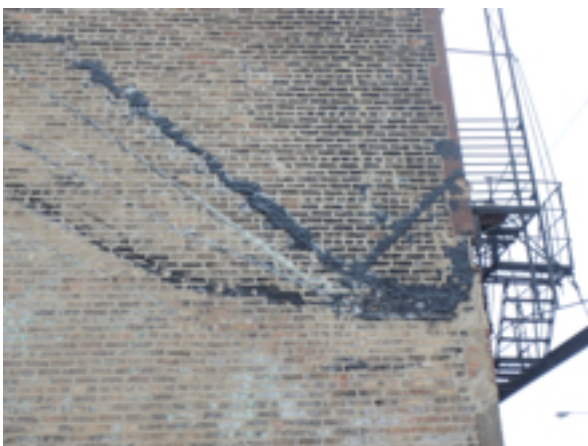
Likely from previous building

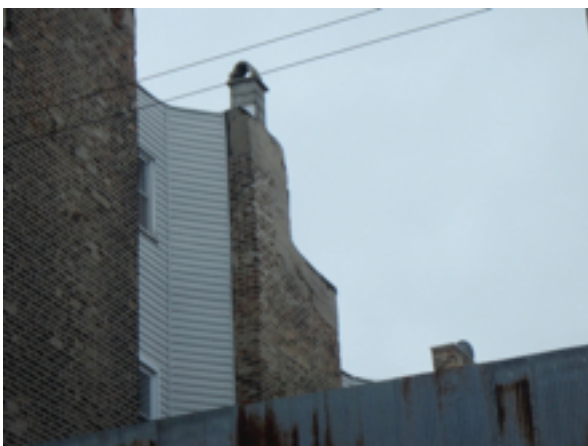
W elevation view, wall mostly ok but parapets need work

- Don't forget to budget for siding and roofing repairs at the W elevation light well
- If you decide to install storefront AC or make up air equipment on the W light well roof, replace the roof first

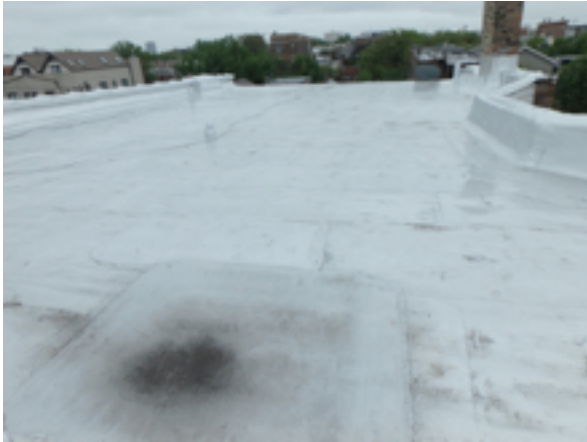
General roof views, some wrinkled and bubbles not no major heaving

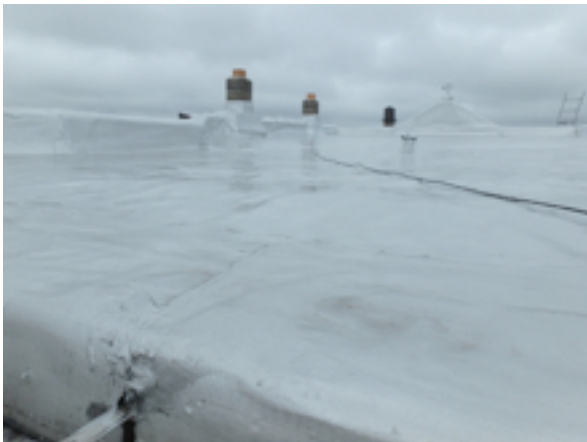
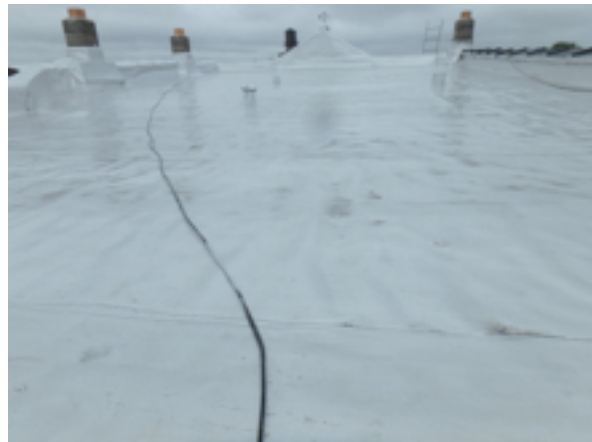
Upper roof views, mostly flat, assessment difficult due to newer silver coating

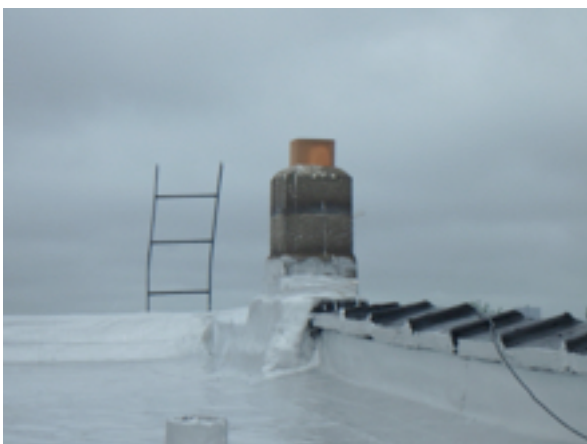
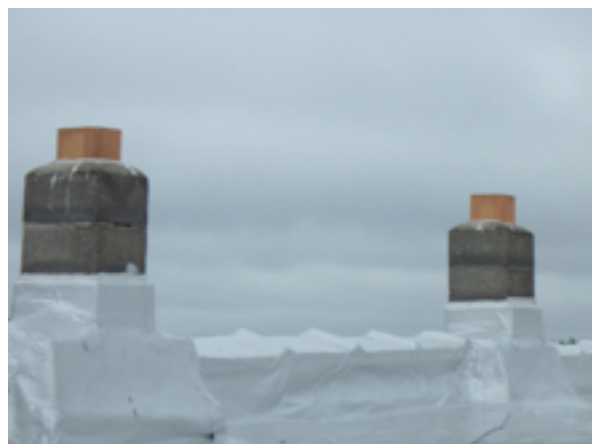
Chimney views, these block chimneys need rain hats and proper caps to keep water out of the long term

- The top of the chimney needs either a proper cap and rain hat or to be closed off to stop water coming into the wall
- Chimney closure cost is far less than what wall repair costs will be if the chimney isn't dealt with

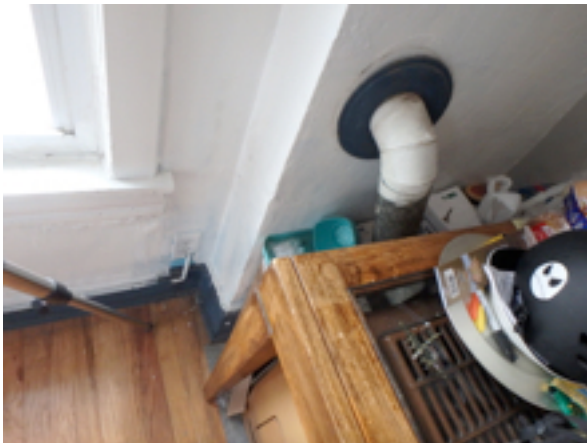
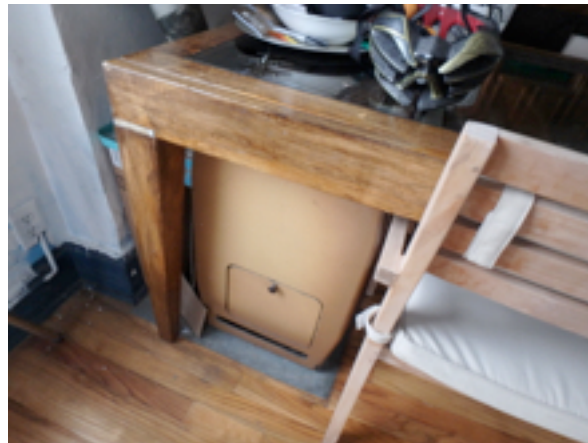
4th floor apartment space heater in Dangerous & Hazardous condition, flue pipe disconnected at back of unit and open to wall; **DO NOT** allow tenant to use

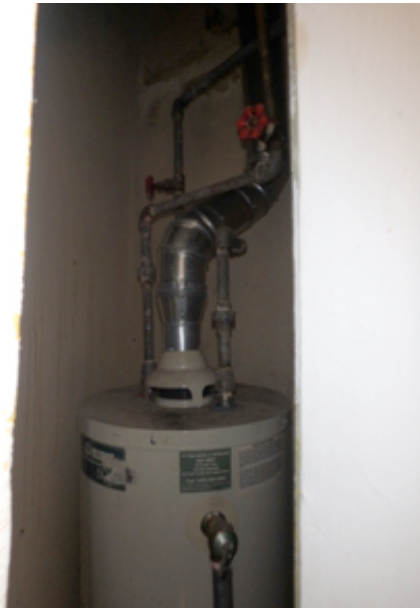
Typical water heaters in kitchens and closets, budget for full replacements

- New water tank installations will require proper TPR discharge pipes and NO shut off on the hot outlet side of the tank
- Depending on what you do with the storefront PVC drain pipe will probably not be allowed. You'll probably need to budget for cast and copper installations
- If some of the proposed Code relief items being discussed get approved you might end up being able to do PVC though

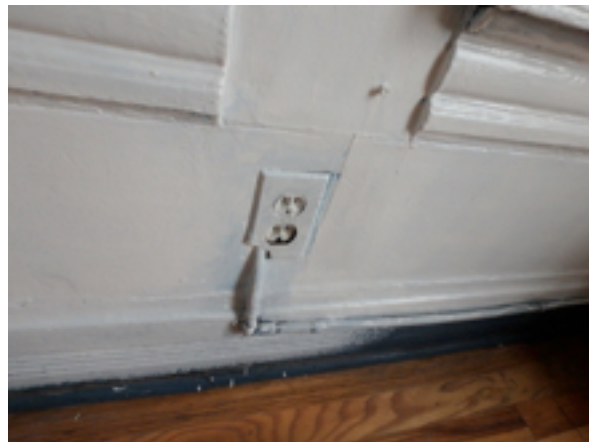
Typical poor and damaged electrical infrastructure in building

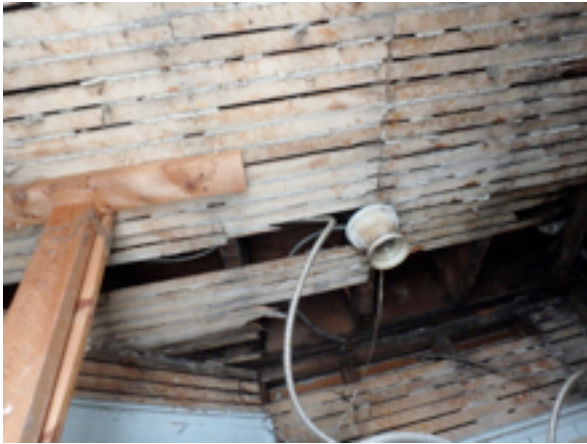
Not exactly functional lights at multiple locations

- Tenants using lots of extension cords to make up for poor lighting and lack of sufficient modern receptacles. This can pose additional electrical fire concerns
- The above open ceiling area is located above the dropped ceiling in one of the apartment bathrooms
- All painted receptacles need to be replaced

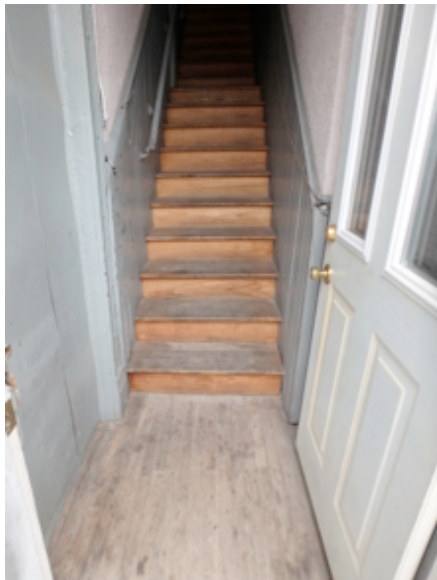
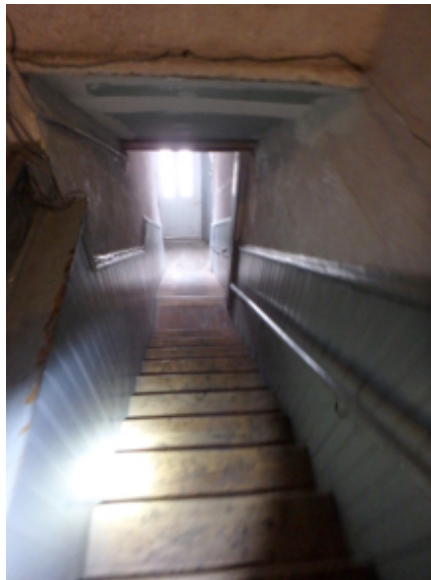
Stairwell views, stairs could be sanded and refinished; wood panels could be serviced and painted

- The missing guardrail above should be considered a hazardous condition. If a tenant falls costs will be much higher than installing a guardrail
- While the stairwells and corridors don't look too good they actually in fairly decent shape
- The bottom wall panels and wood trims can easily be saved. Upper walls and ceilings need to be scraped down, patched and painted at the very least
- Stripping plaster down to lath and installing new drywall might be the better option though
- Sanding and refinishing the wood stairs tends to be your best long term option

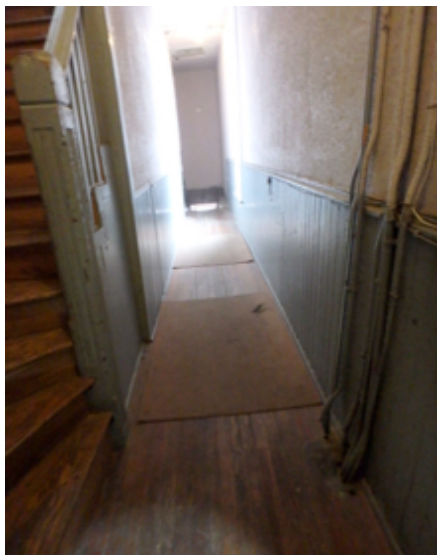
Typical corridor view, overall not bad

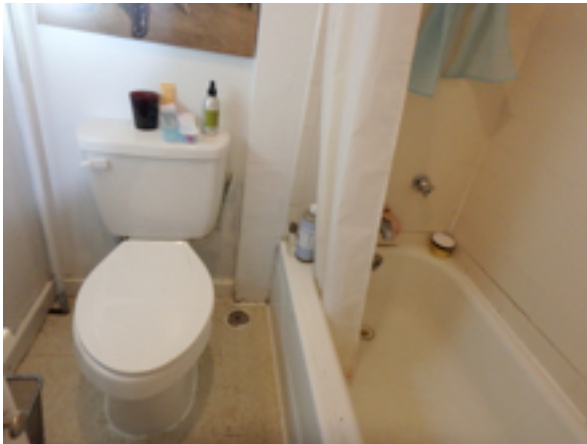
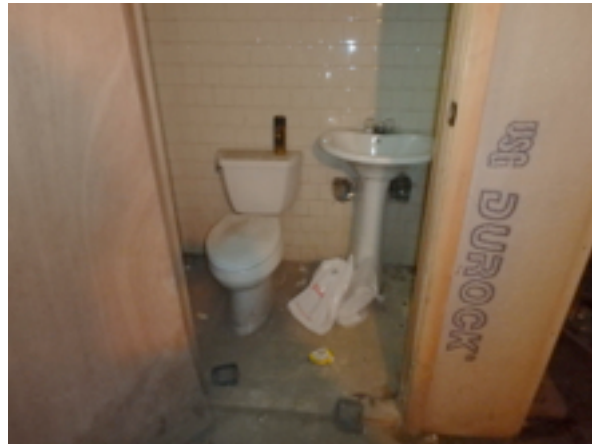
Typical basic bathroom installations, overall not too bad

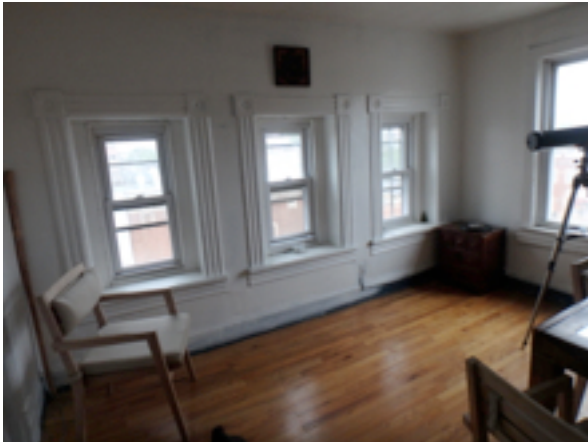
General conditions look good but the details show the problems

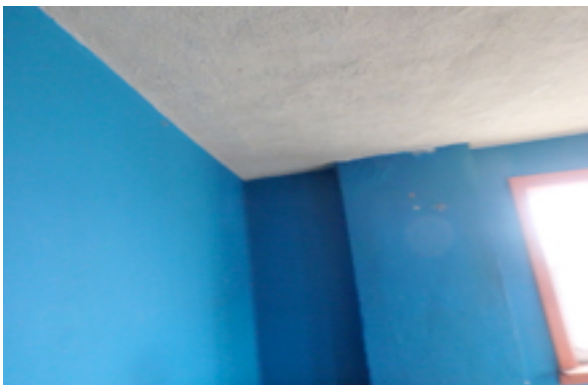
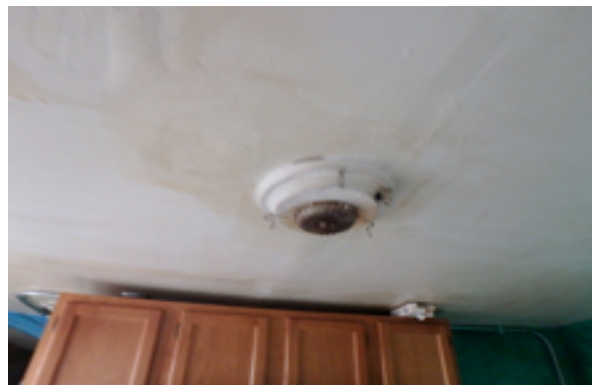
Typical older wall and ceiling conditions with wear and damage

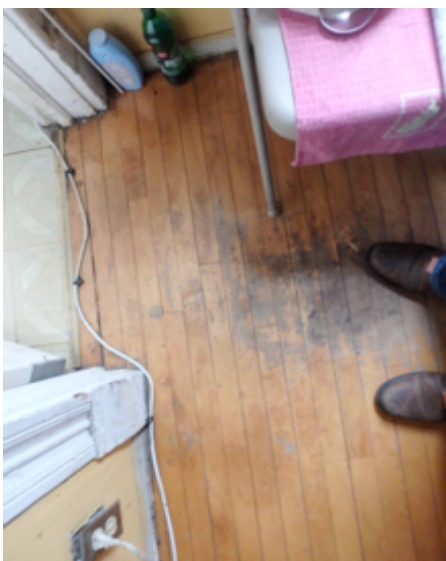
Some floors look ok, some floors a bit rough, sanding and refinishing should be fine

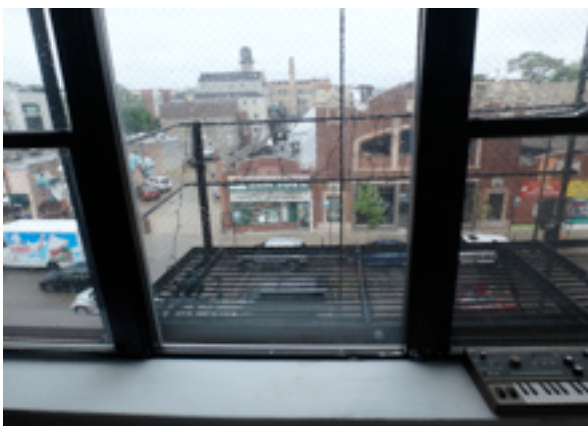
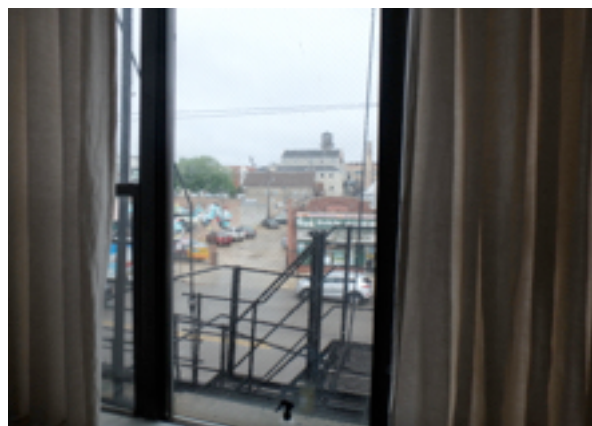
If the fire escape remains in place, wired glass window assemblies need to remain in place as well

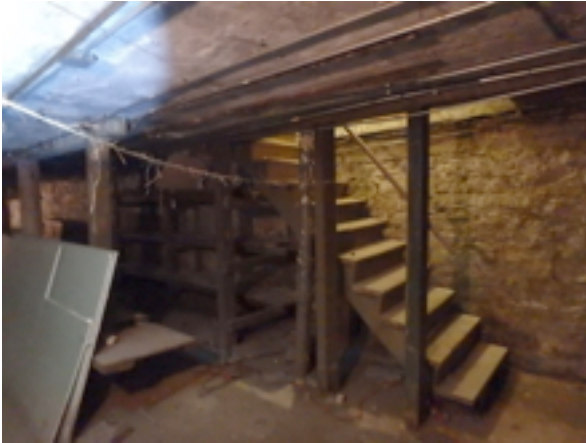
Basement stairway view and flood line along drywall

- The basement is a flood and rat disaster at this point. Moisture levels are very high; termite type damage is evident at some wood components; and structural problems are abundant.

- Full gut down to cement floors, exterior foundation walls and ceiling joists is the recommended option in order to have a space you can fully assess and rehab for sound occupancy condition

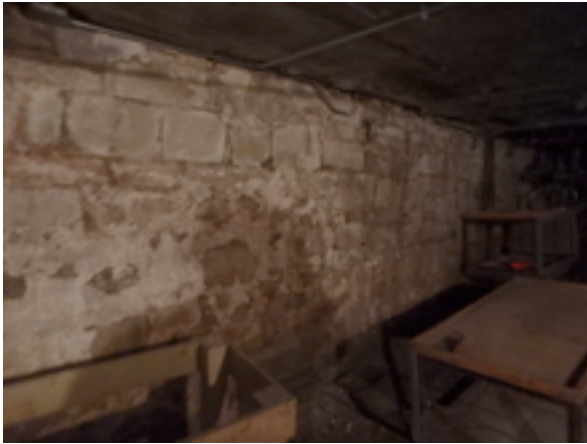
Typical old stone foundation walls with erosion

- Power wash foundation walls to remove all loose debris, hire a qualified Mason to provide foundation wall repairs
- All the interior repairs will NOT keep water out if you don't also provide the needed exterior repairs such as concrete replacements, downspouts and grading

- Depending on conditions you may also need to install a membrane or perimeter drain tile in the basement for water management

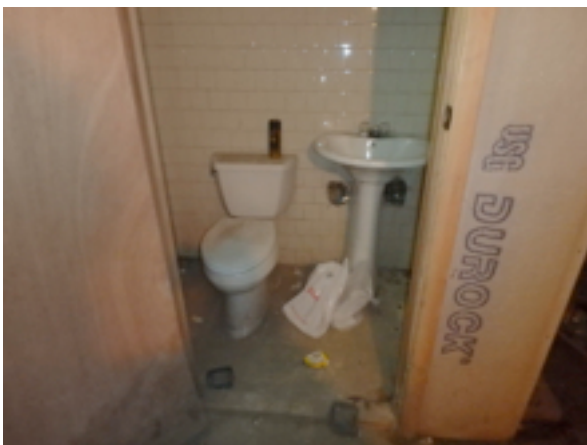
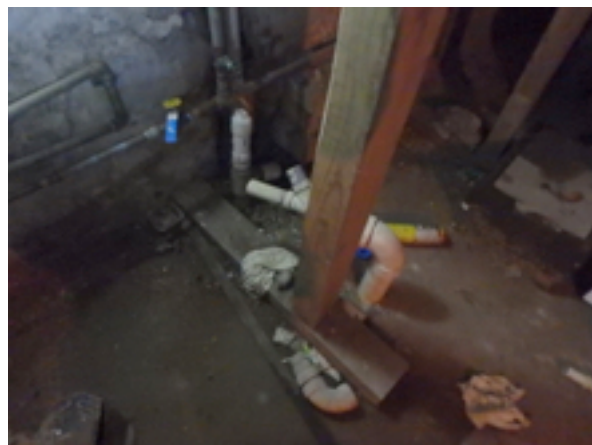
Basement bathroom and plumbing with non-compliant PVC piping

- Depending on how you are going to view storefront rehab and rental, installing a compliant basement bathroom might be very helpful as an employee bathroom.
- Depending on storefront occupancy there are employee bathroom requirements

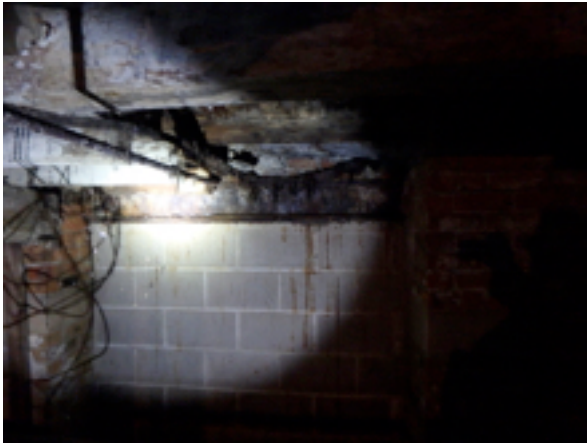
Front CMU wall with extensive rust and water intrusion signs

- My recommendation is that you open a couple exploratory holes to assess what is on the other side of the wall. Is there still a hollow sidewalk vault, a partially back filled sidewalk vault or a full wall of dirt.

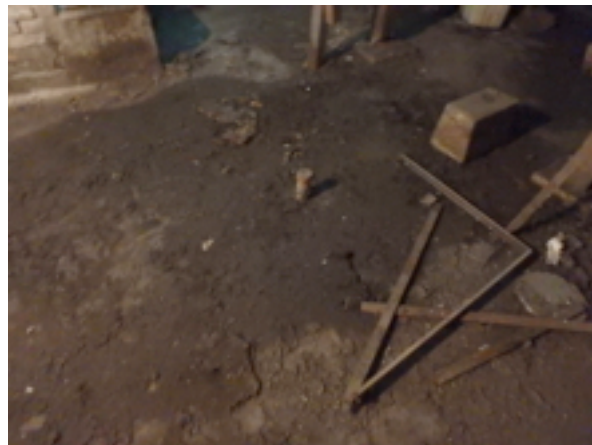
Flooding signs

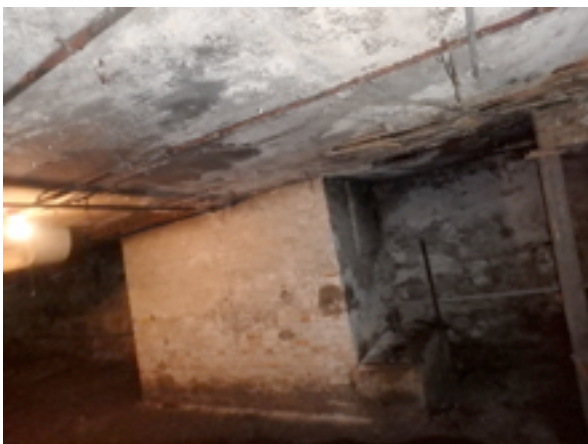
Side enclosure likely for old coal storage or tank area

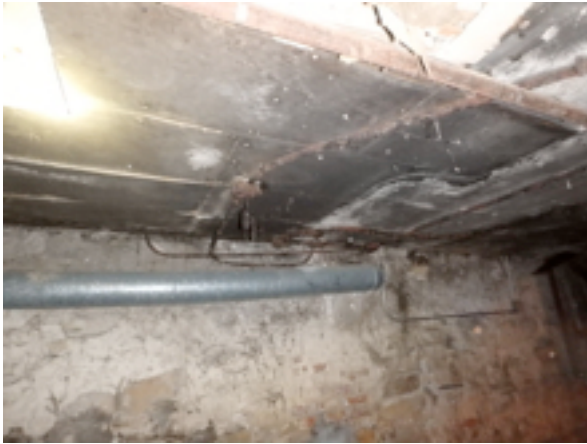
Typical poor ceiling conditions, all needs to be stripped up to joists

- The basement does not have any natural or mechanical ventilation currently. I suggest you budget to provide mechanical ventilation or 1-2 windows at the rear wall.
- Installing a couple windows at the rear wall would be your best overall option for ventilation. The easiest way to have a bad basement is not to have ventilation
